Gearbox Reliability Collaborative Gearbox 1 Failure Analysis Report

December 2010 – January 2011

R. Errichello and J. Muller
GEARTECH
Townsend, Montana

Subcontract Report
NREL/SR-5000-53062
February 2012

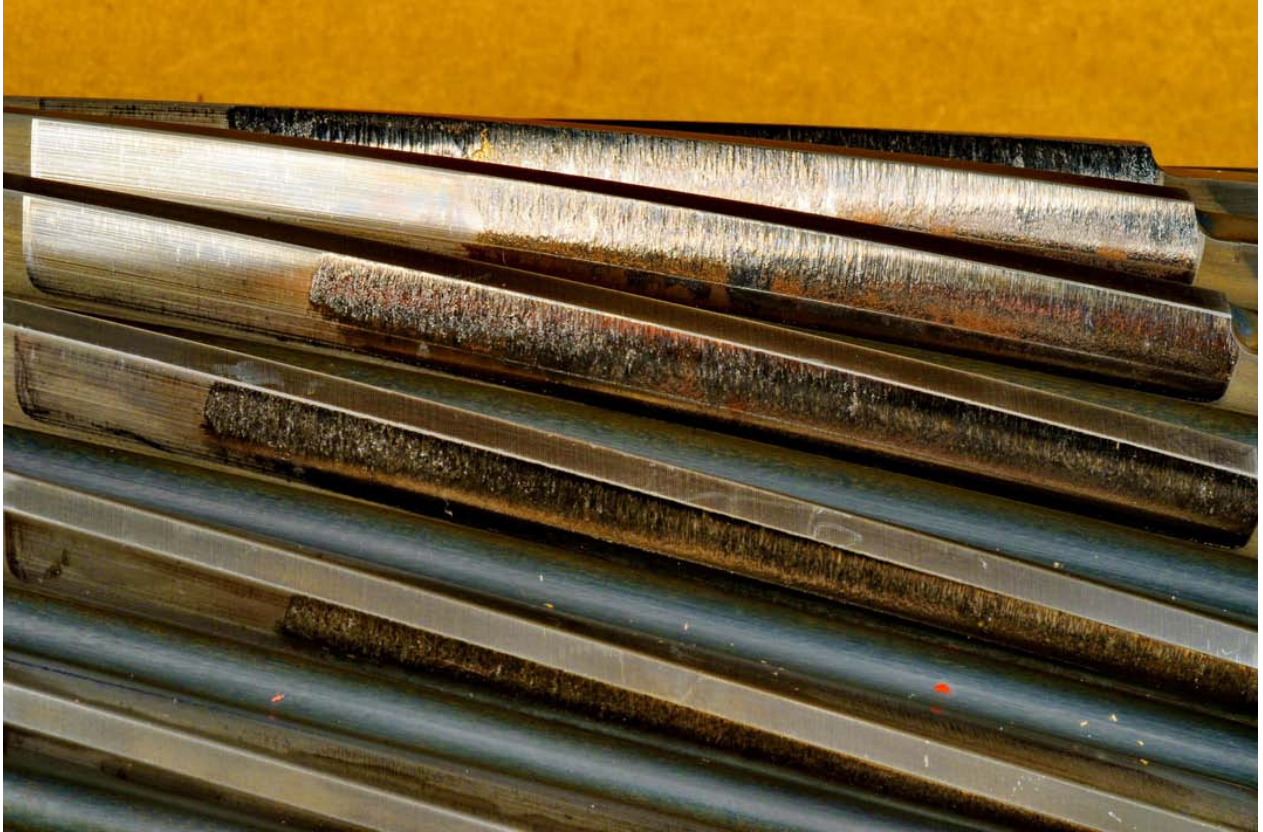
Figure No: 3 (NREL PIX 19860)

1. The primary failure mode of the HS gearset was severe scuffing. The root cause of the failure was probably lubricant starvation. The wear pattern indicates the HS gear mesh was misaligned causing a higher load at the rotor end of the teeth.

Failure mode: scuffing

Failure mode severity: severe

Description: Flanks have scuffing that is biased toward the rotor end of the pinion and varies from 65 to 105 mm wide in a sinusoidal pattern.

Figures 3-6 show severe scuffing on the HS gearset. The scuffing is biased toward the rotor end of the pinion, indicating that the HS gear mesh was misaligned. Furthermore, the scuffing varied in a sinusoidal pattern around the pinion and gear, indicating that there was runout in the pinion, gear, or both. The misalignment could be caused by lead error in the pinion, gear, or both, or by inaccuracy in the gear housing bores. Therefore, the HSP, HSG, and gear housing bores should be inspected to determine the source of the misalignment of the HS gear mesh. Endplay in the HS bearings A1/A2 was within specified tolerance. Therefore, bearing internal clearance did not contribute significantly to the misalignment.

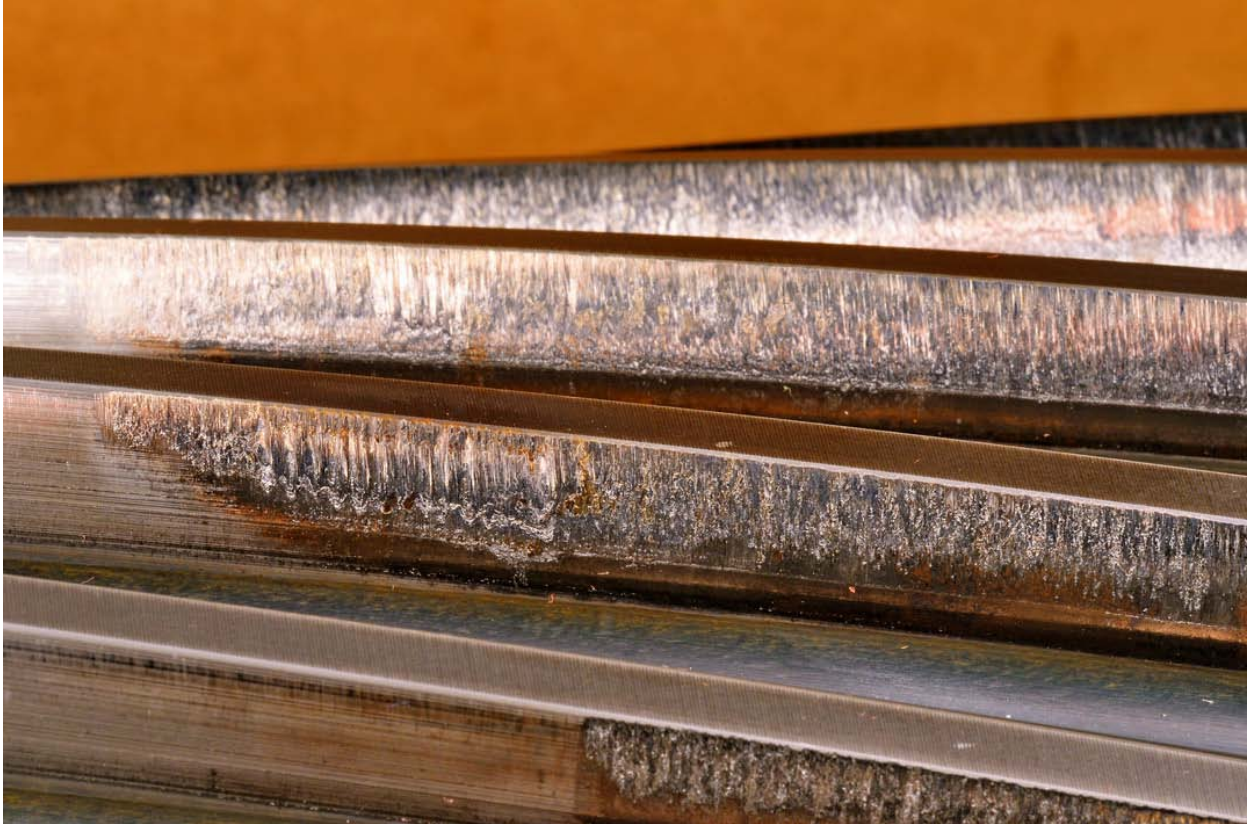
Figure No: 4 (NREL PIX 19861)

Failure mode: scuffing

Failure mode severity: severe

Description: Same as Figure 1 except closeup view.

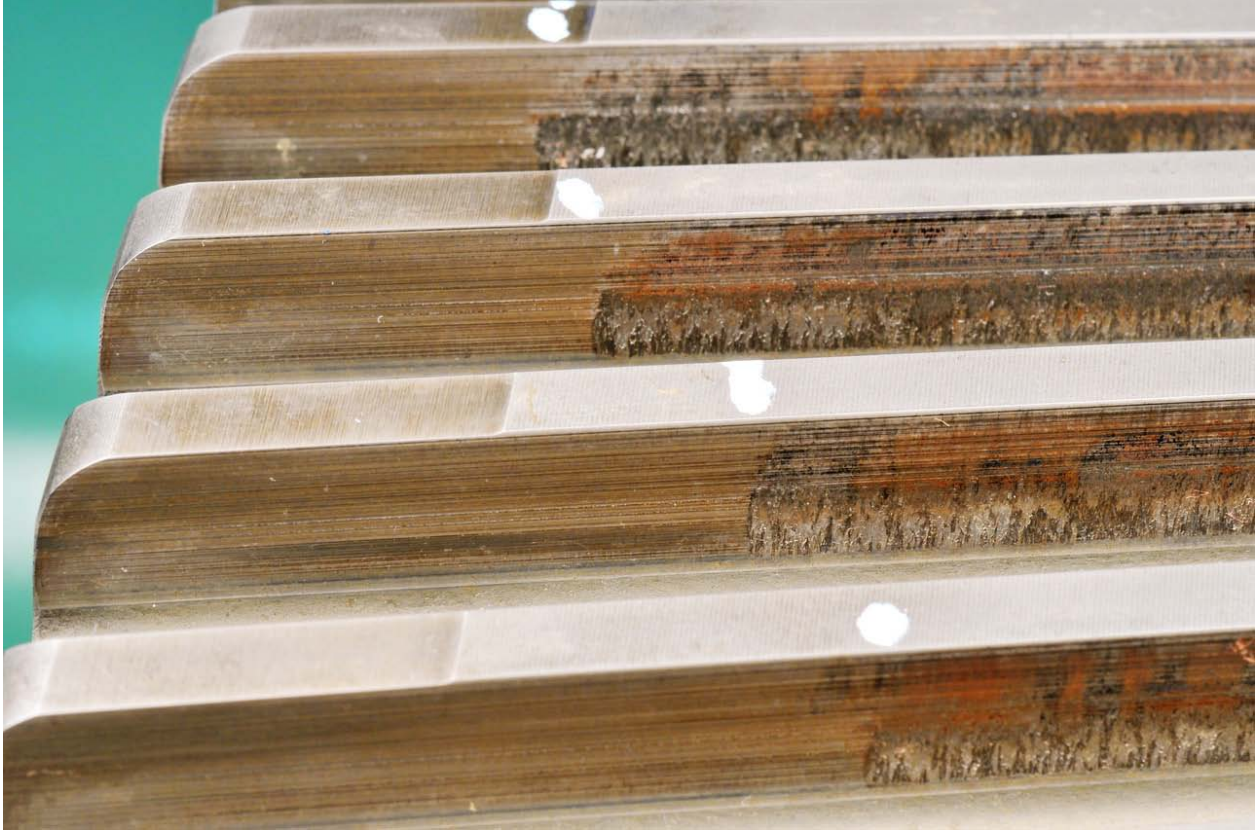
Figure No: 5 (NREL PIX 19871)

Failure mode: scuffing

Failure mode severity: severe

Description: Flanks have scuffing that is biased toward the rotor end of the gear and varies from 65 to 105 mm wide in a sinusoidal pattern.

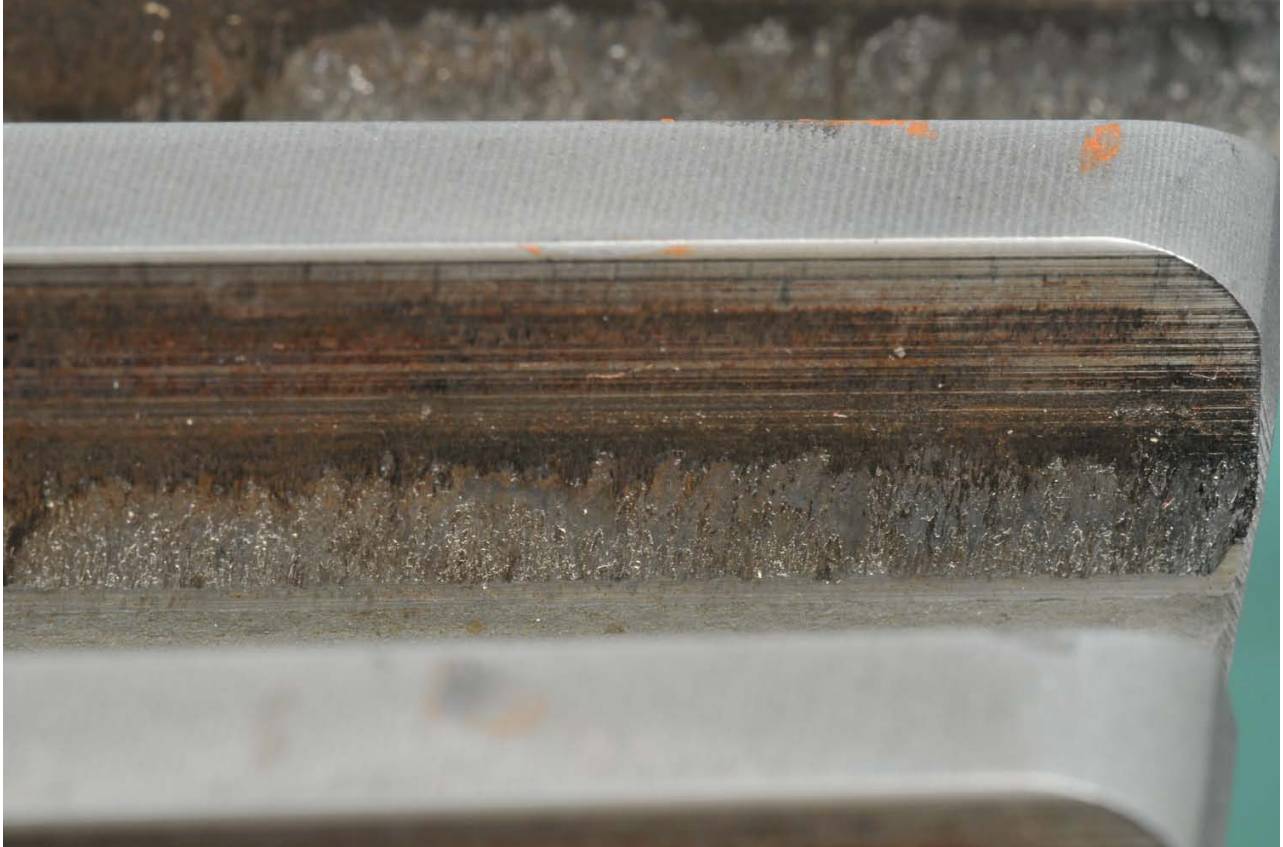
Figure No: 6 (NREL PIX 19872)

Failure mode: scuffing

Failure mode severity: severe

Description: Scuffing is concentrated in the dedenda and corresponds to the scuffing on the pinion addenda. Original grind marks are present in the addenda.

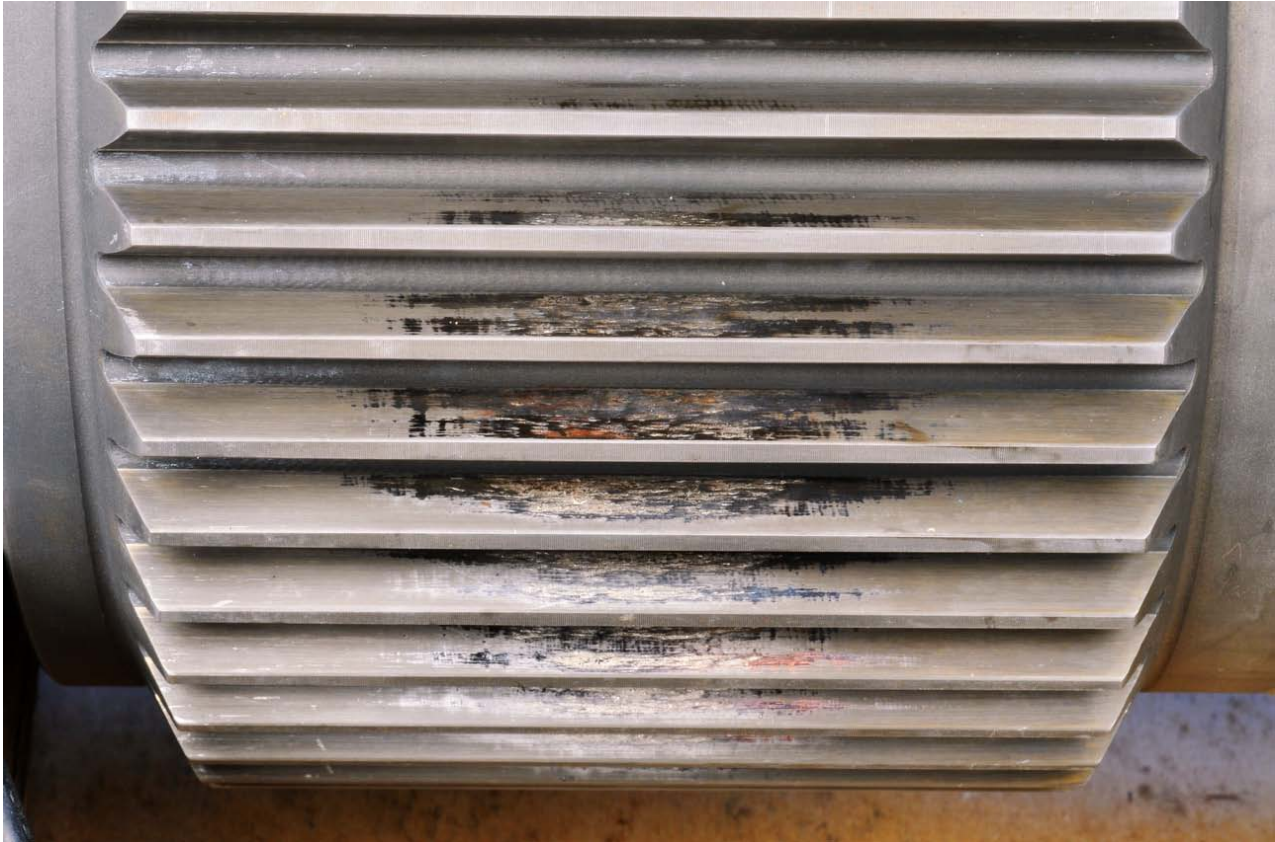
Figure No: 7 (NREL PIX 19852)

2. The primary failure mode of the sun spline was severe fretting corrosion. The root causes of the failure were probably lubricant starvation and poor load distribution (only about 50% of the teeth carried the load).

Failure mode: fretting corrosion

Failure mode severity: severe

Description: Fretting corrosion is concentrated in the midface and is most severe at the high point of the lead crown. Tooth-to-tooth contact varies from no contact to heavy contact. Only about 50% of the teeth carried the load.

Figures 7-8 show severe fretting corrosion on the sun spline. The damage was centralized on the spline teeth, but varied in severity around the spline, with only about 50% of the teeth carrying the load. The load zones were about 180° apart, indicating that the external or internal spline was out of round. The accuracy of the internal spline is expected to be lower than the external spline because it was shaper cut. Cutting is less accurate than grinding, and the internal spline was nitrided, which imparts some distortion.

Because the external spline was carburized and ground, the internal spline was nitrided, and the spline was force-lubricated. It should have been resistant to fretting corrosion. Therefore, the root causes of the failure were probably lubricant starvation and poor load distribution.

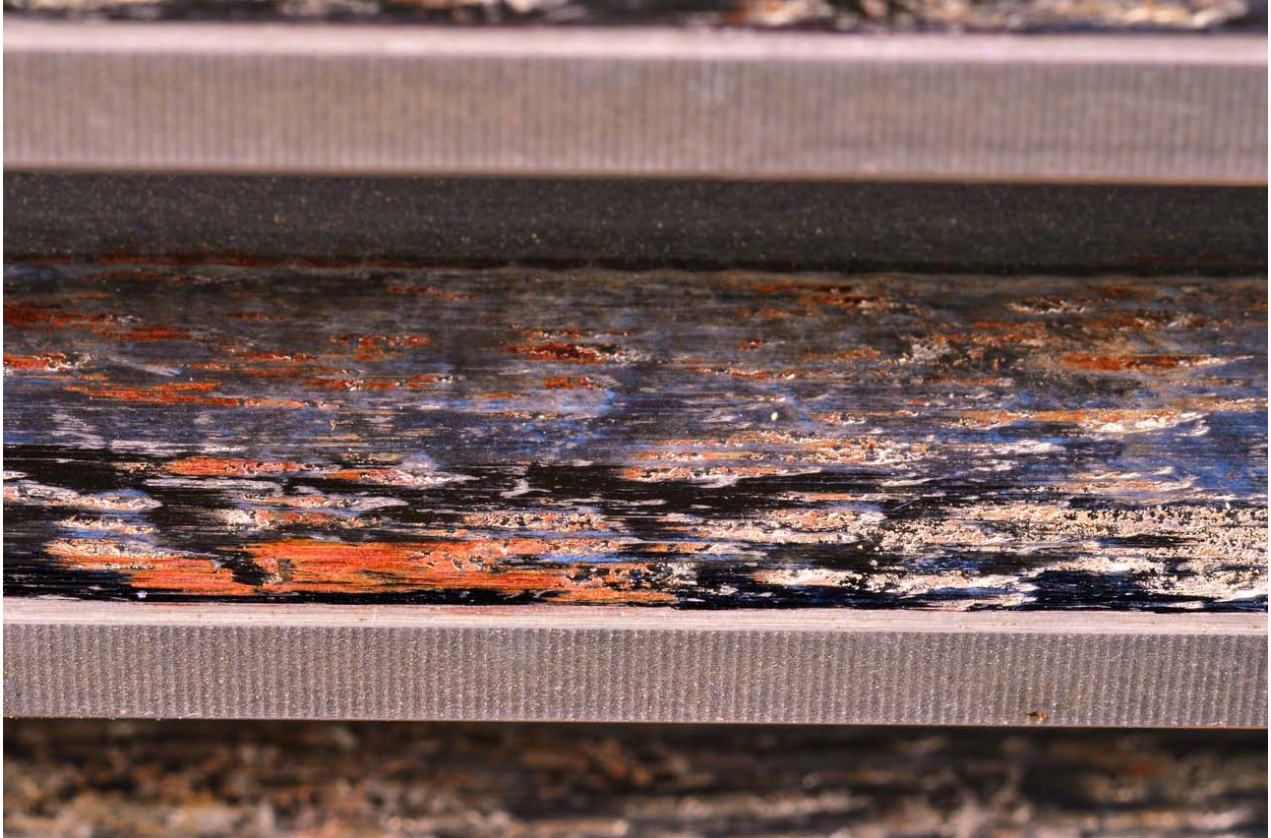
Figure No: 8 (NREL PIX 19853)

Failure mode: fretting corrosion

Failure mode severity: severe

Description: Closeup view of a tooth with severe fretting corrosion. Adhesion between the external sun spline and the hollow shaft internal spline transferred lumps of material from the hollow shaft. Axial sliding broke the welds and deformed the material in the axial direction. The red debris is hematite (Fe₂O₃). Hematite is a polishing agent that created polishing wear that surrounds the fretting damage.

Adhesion between the external sun spline and the hollow shaft internal spline transferred lumps of material from the hollow shaft. Axial sliding broke the welds and deformed the material in the axial direction. The red debris in Figure 8 is hematite (Fe_2O_3). Hematite is a polishing agent and it created the polishing wear that surrounds the fretting damage.

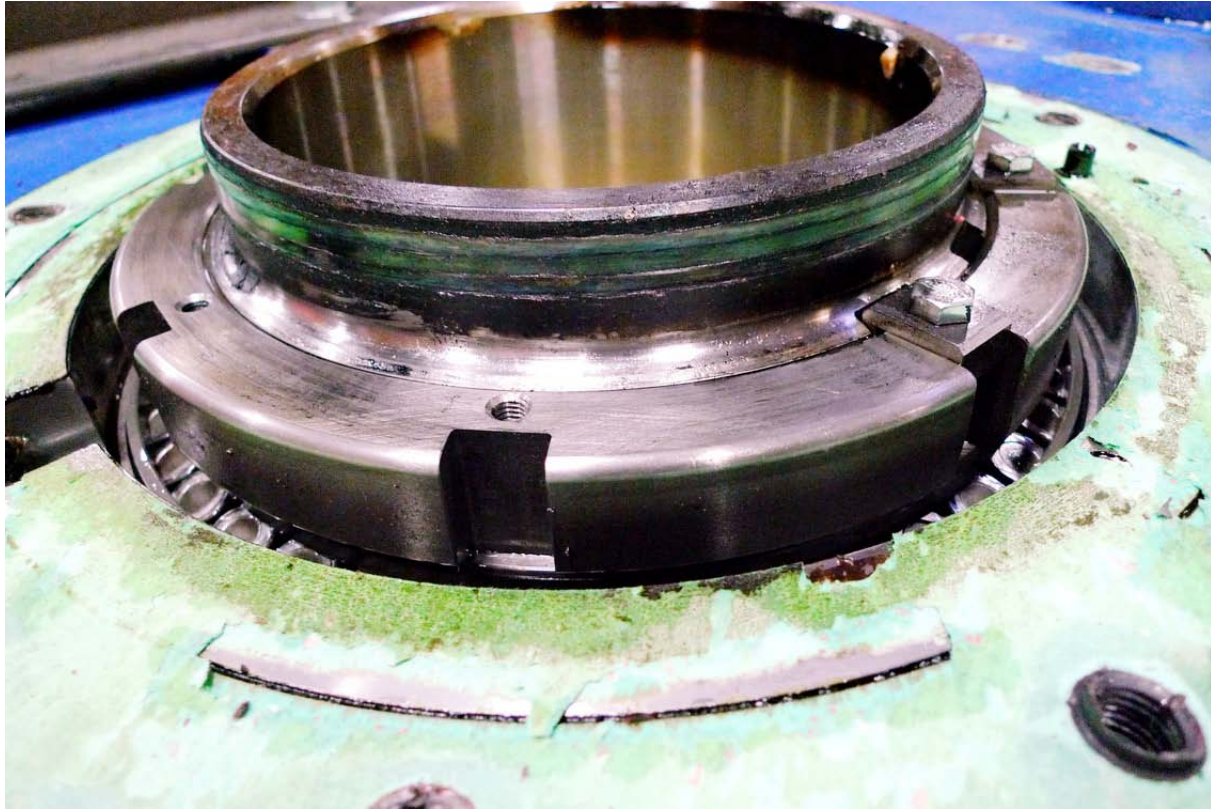
Figure No: 9 (NREL PIX 19837)

3. The primary failure mode of the "O"-ring/hollow shaft seal was severe scuffing and vaporization of the "O"-ring. The root cause of failure was excessive endplay in the TRB bearings E1/E2, which was caused by wear on the bearing locknut due to spinning of the IR of bearing E1.

Failure mode: scuffing

Failure mode severity: severe

Description: View of the hollow shaft extension that rubbed on the “O”-ring seal plate. The rubbing caused severe scuffing on the hollow shaft and “O”-ring seal plate. The “O”-ring vaporized. The green gasket is broken in many places indicating that it is brittle.

Figures 9-11 show severe scuffing on the hollow shaft and the “O”-ring seal plate. Excessive endplay in the TRB bearings E1/E2 caused the hollow shaft to rub on the “O”-ring plate resulting in severe scuffing on the hollow shaft and “O”-ring seal plate. The “O”-ring vaporized.

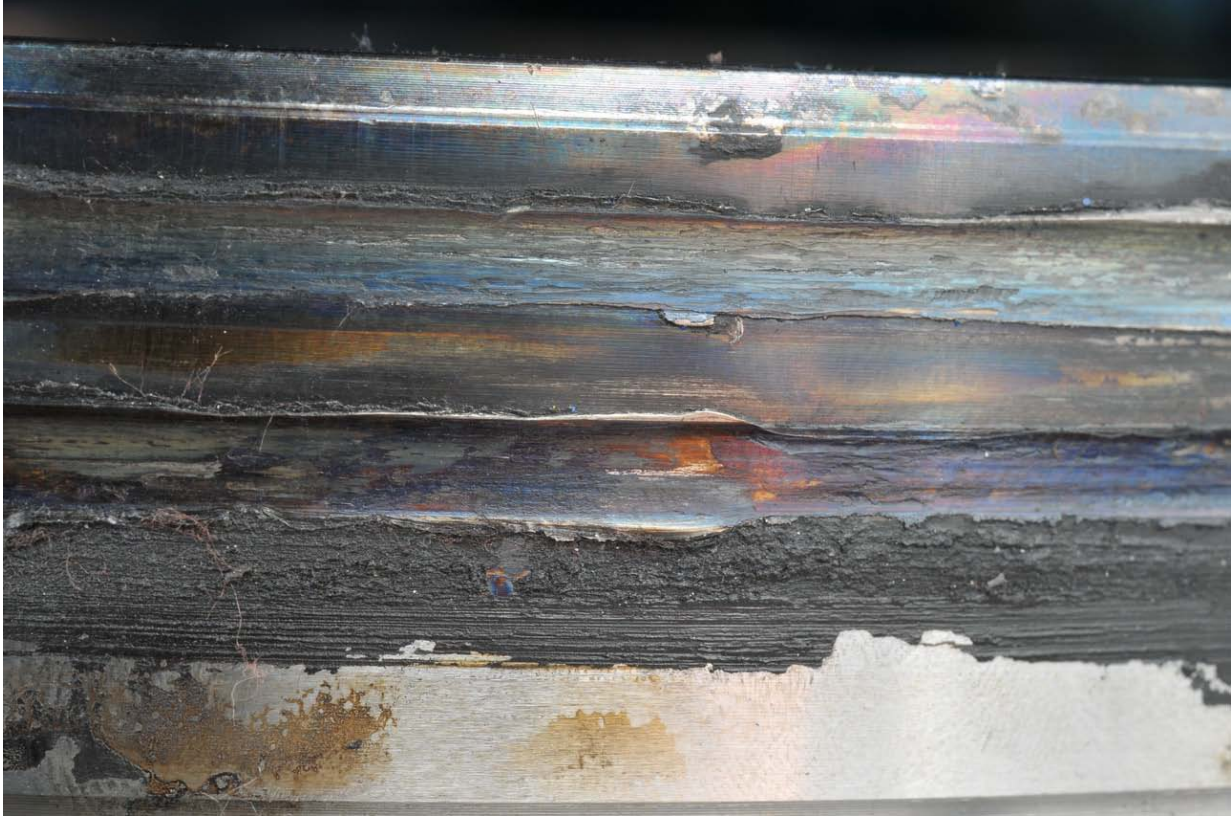
Figure No: 10 (NREL PIX 19875)

Failure mode: scuffing

Failure mode severity: severe

Description: Closeup view of the hollow shaft extension that rubbed on the “O”-ring seal plate. The scuffing wore two deep grooves into the hollow shaft. The black coating near the bottom of the photo is debris from the vaporized “O”-ring.

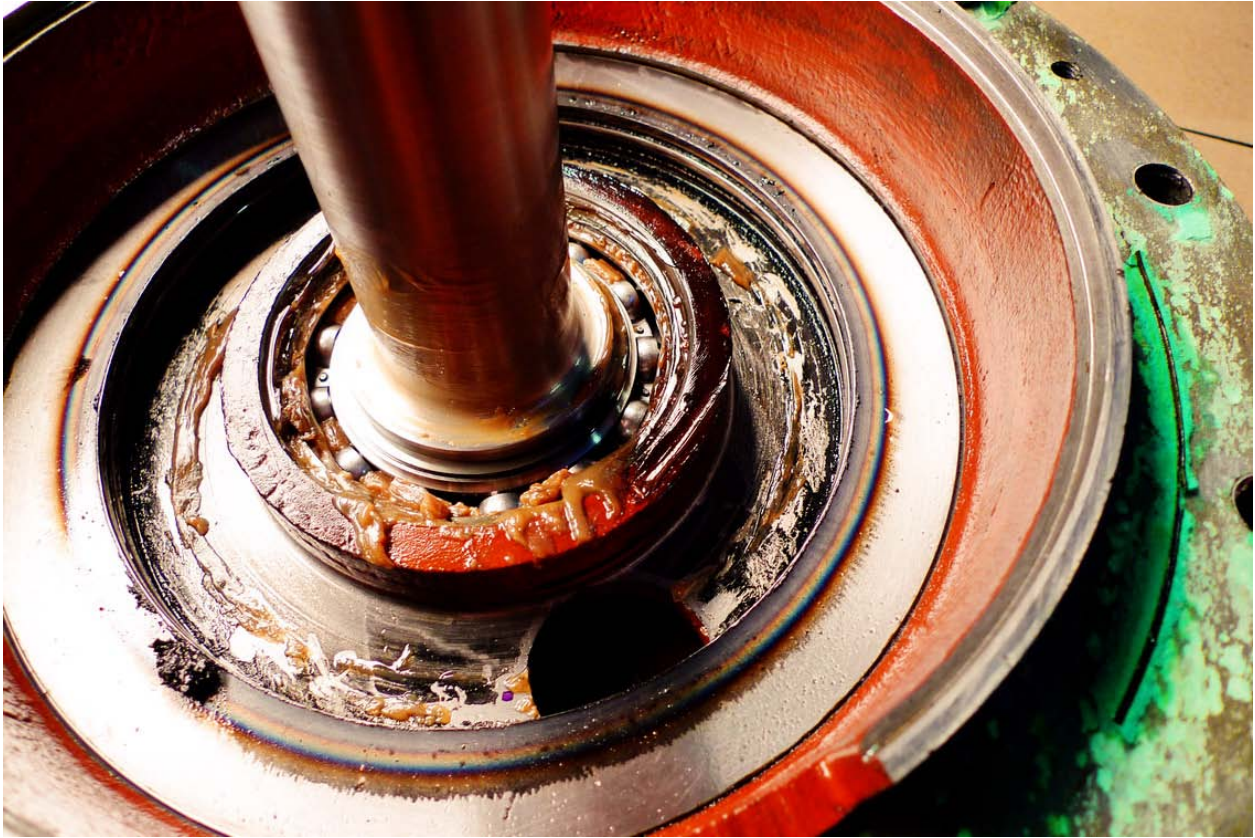
Figure No: 11 (NREL PIX 19838)

Failure mode: scuffing

Failure mode severity: severe

Description: View of the "O"-ring seal plate that rubbed on the hollow shaft. The rubbing caused severe scuffing on the hollow shaft and the "O"-ring seal plate. The "O"-ring vaporized. A lump of melted rubber adhered to the plate. The temper colors near the bore of the "O"-ring seal plate show that the temperature reached at least 700°F.

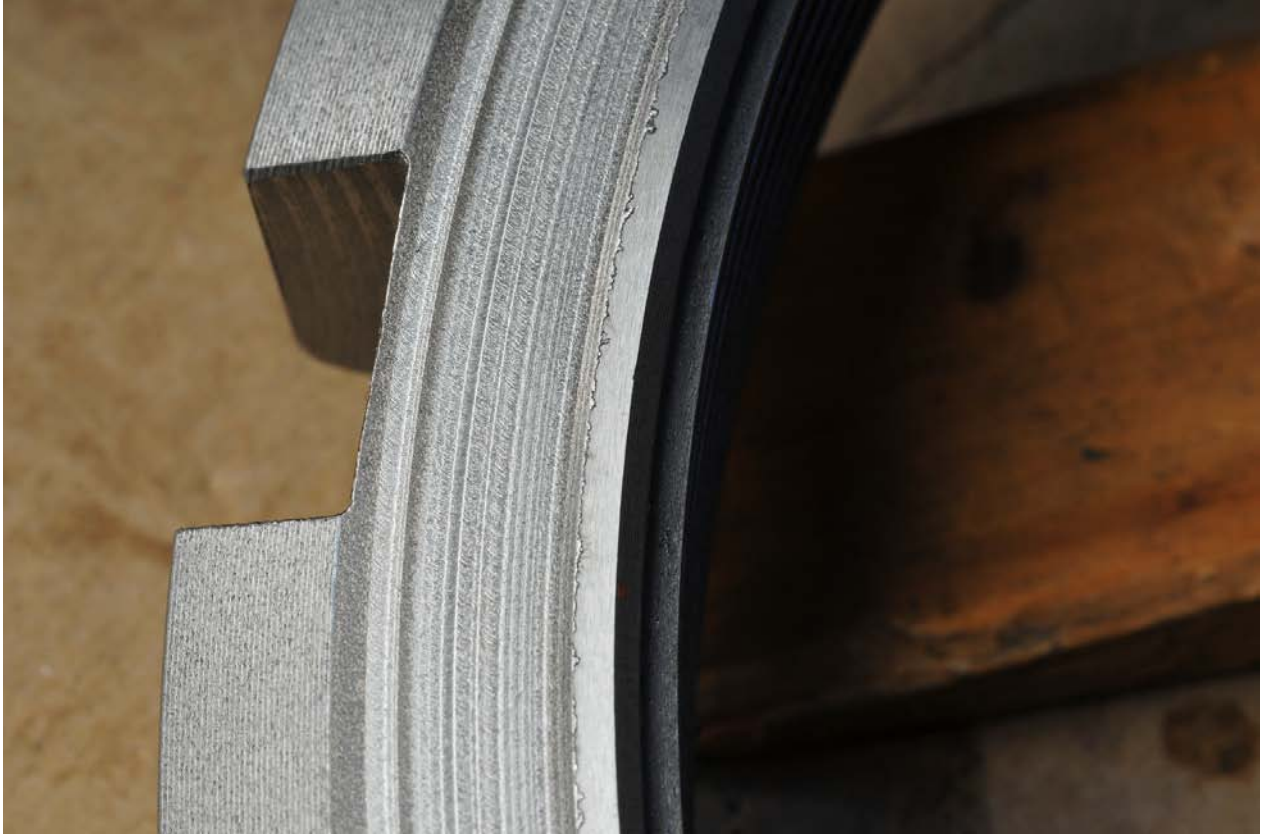
Figure No: 12 (NREL PIX 19874)

Failure mode: abrasion

Failure mode severity: severe

Description: View of the face of the bearing locknut showing severe abrasive wear. Spinning of the IR of bearing E1 caused the bearing E1 IR to rub on the locknut.

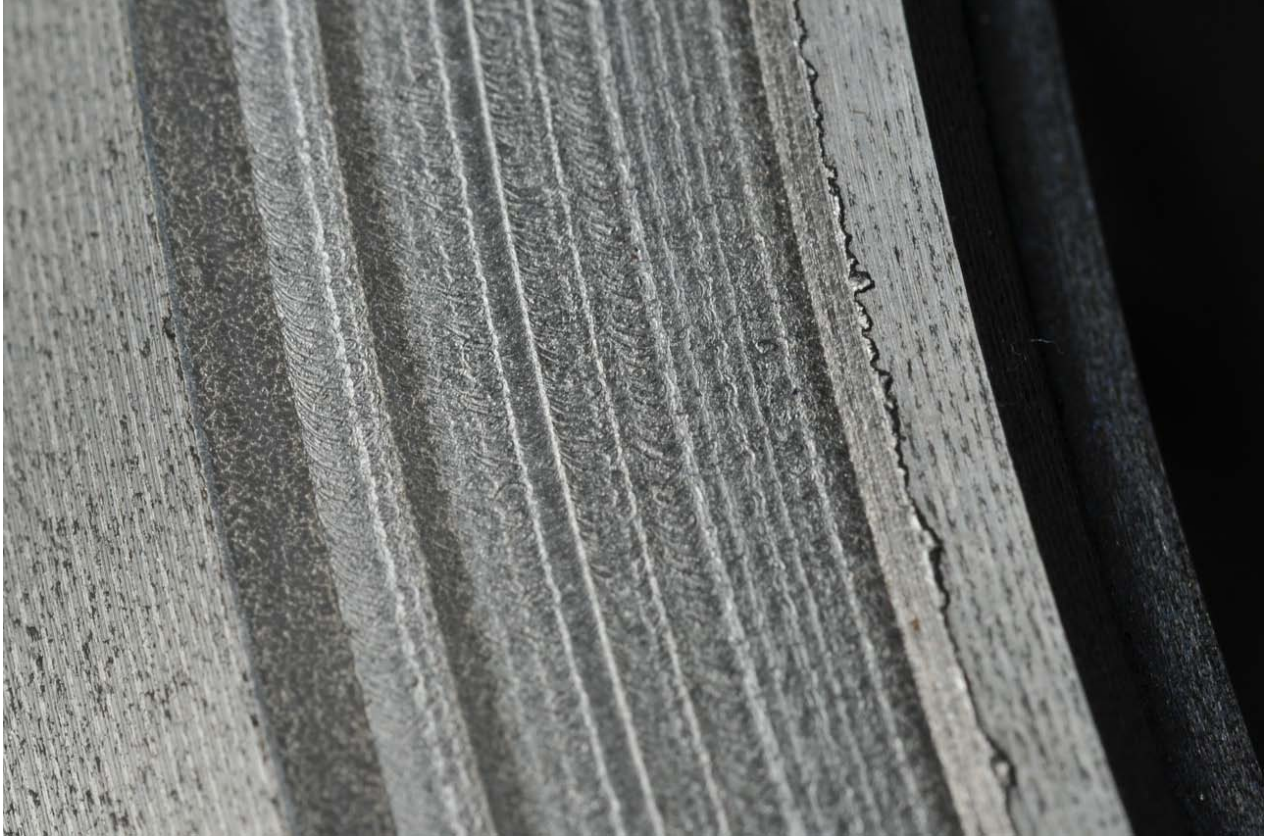
Figure No: 13 (NREL PIX 19873)

Failure mode: abrasion

Failure mode severity: severe

Description: Closeup view of the face of the bearing locknut. Abrasion removed 0.27 mm from the face of the locknut. The end face of bearing E1 IR also was worn, but to a lesser degree than the locknut.

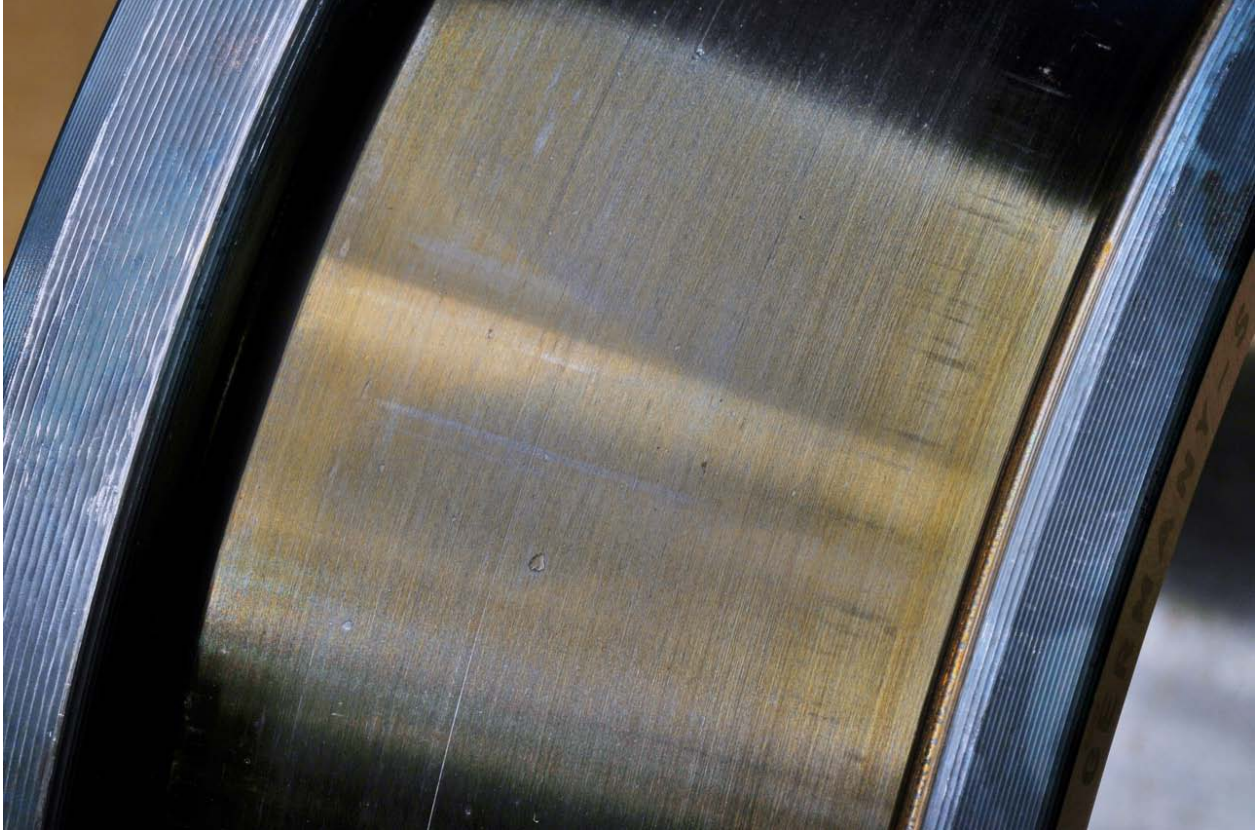
Figure No: 14 (NREL PIX 19858)

4. Bearing A1 overheated. Straw-yellow temper color indicates that the temperature reached about 400°F. The root cause of the overheating was probably lubricant starvation.

Failure mode: overheating

Failure mode severity: mild

Description: Mild overheating created straw-yellow temper colors near each end of the IR raceway. The temper colors show that the temperature reached about 400°F.

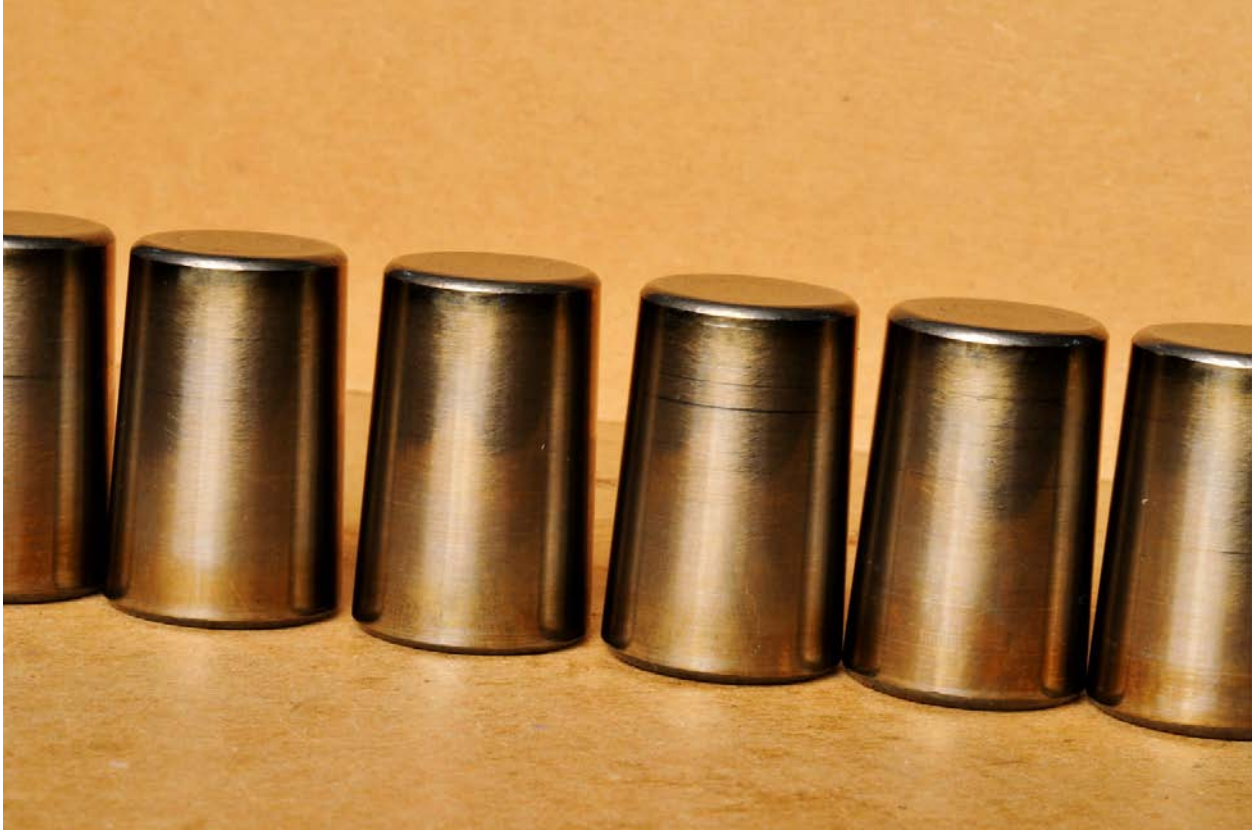
Figure No: 15 (NREL PIX 19859)

Failure mode: overheating

Failure mode severity: mild

Description: Mild overheating created straw-yellow temper colors near each end of the rollers. The temper colors show that the temperature reached about 400°F.

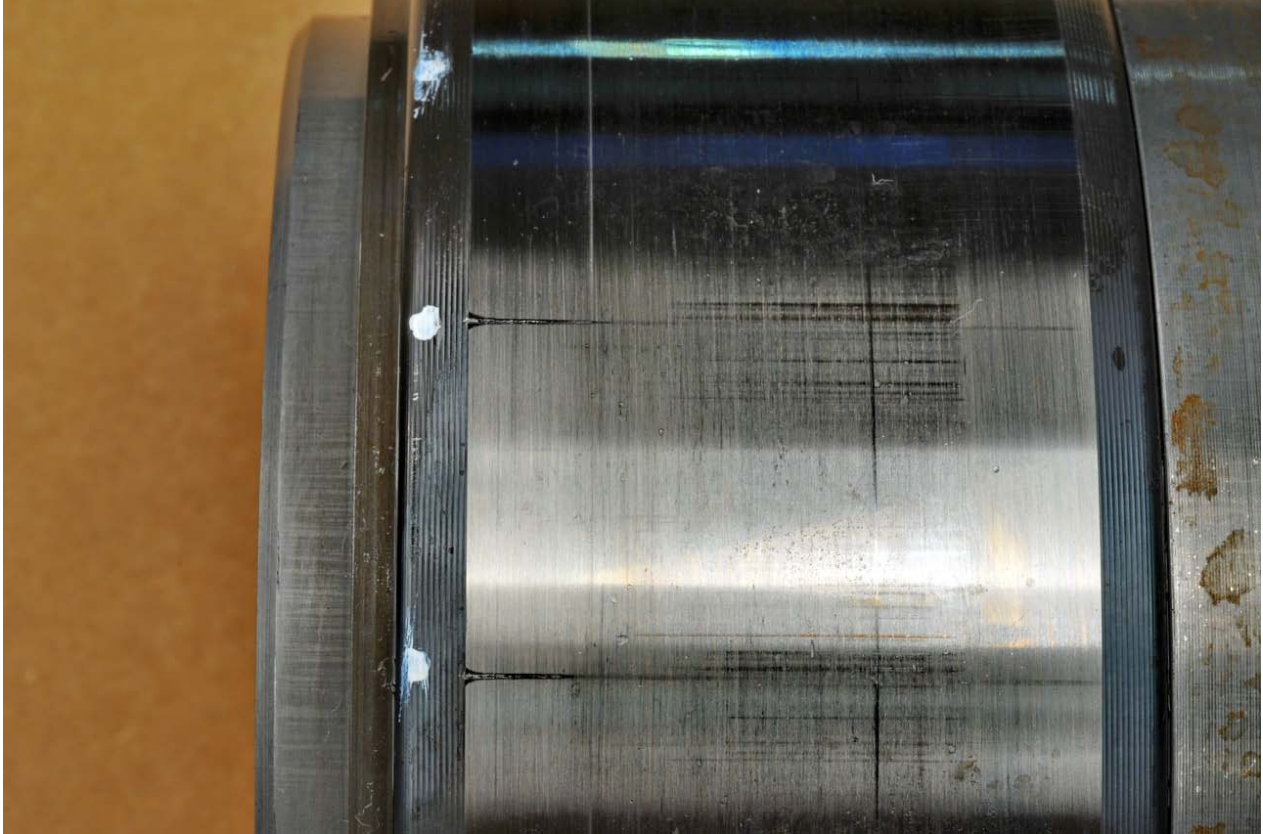
Figure No: 16 (NREL PIX 19864)

6. The IR of bearing D had assembly damage at the roller spacing caused by a cocking of the rollers during blind assembly.
7. The spacer for bearing C1/C2 ORs had assembly damage at the roller spacing caused by interference with the bearing rollers during assembly.

Failure mode: assembly damage

Failure mode severity: moderate

Description: Three lines of plastic deformation and scuffing at the roller spacing indicate that the rollers cocked and jammed on the IR during assembly.

6. Review the assembly procedure for bearing D and revise as necessary to avoid assembly damage.
7. Revise the design of the spacer for bearings C1/C2 ORs to avoid assembly damage.

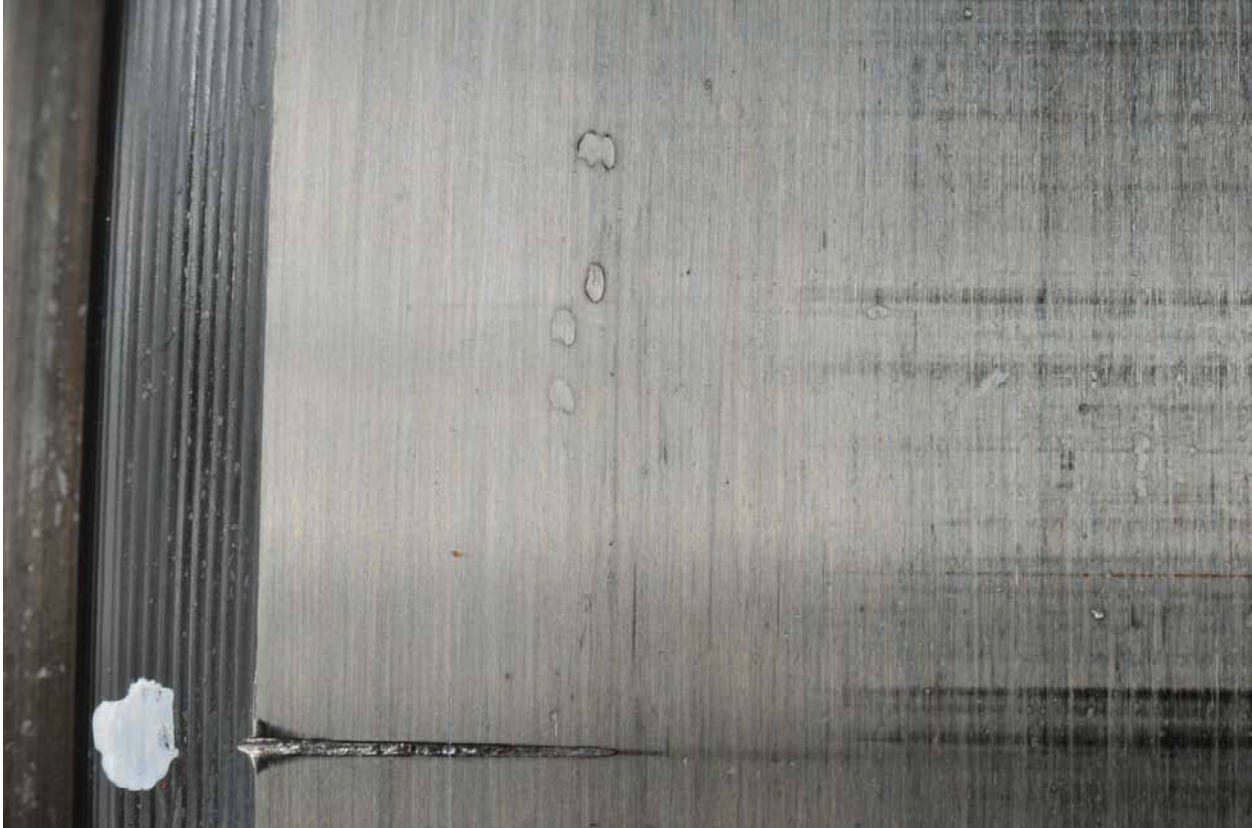
Figure No: 17 (NREL PIX 19865)

Failure mode: assembly damage

Failure mode severity: moderate

Description: Closeup view of assembly damage. Debris dents and lines of false brinelling also are shown.

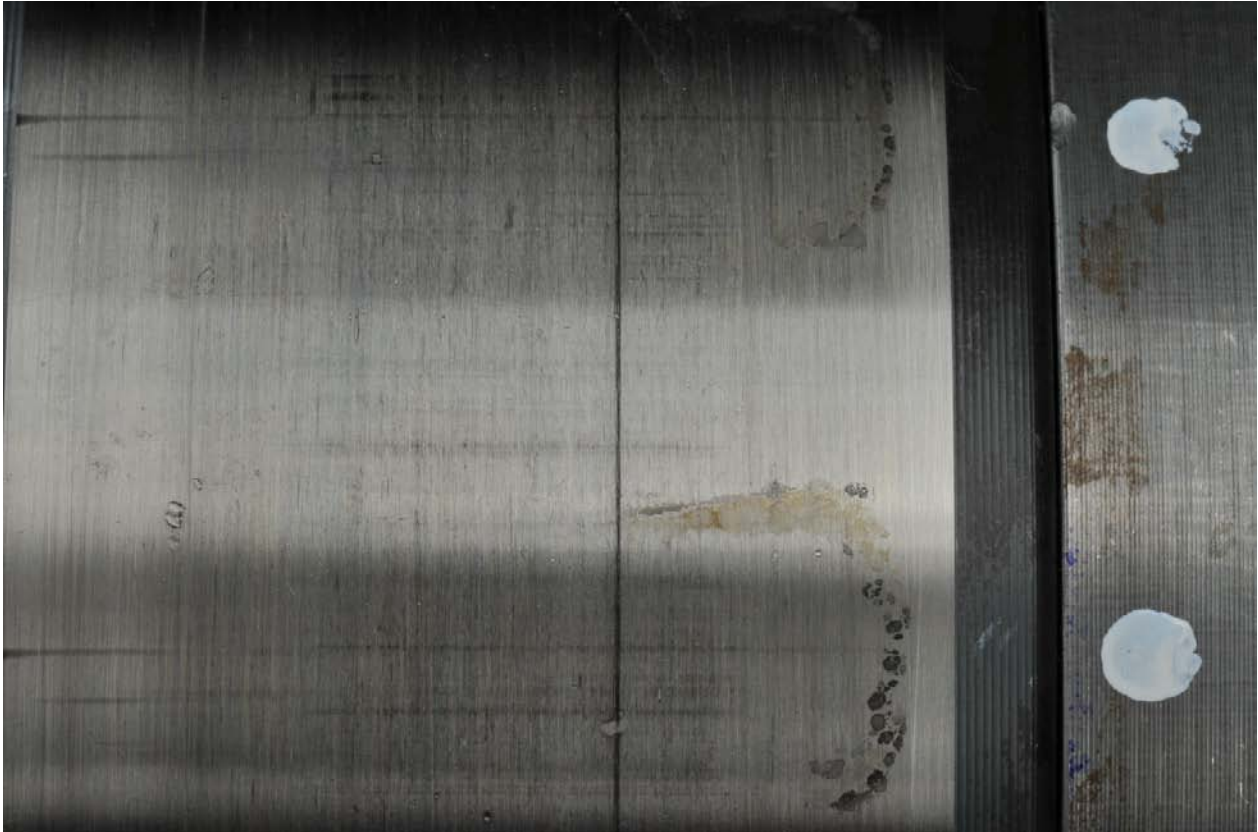
Figure No: 18 (NREL PIX 19866)

8. The IR of bearing D had corrosion at the roller spacing.
9. The sun spherical thrust rings had small patches of fretting corrosion. The root cause of the fretting corrosion was probably lubricant starvation due to malfunction of the bronze transfer ring.

Failure mode: contact corrosion

Failure mode severity: mild

Description: Closeup view of contact corrosion at the roller spacing. Debris dents, false brinelling, and a circumferential line of abrasion also are shown.

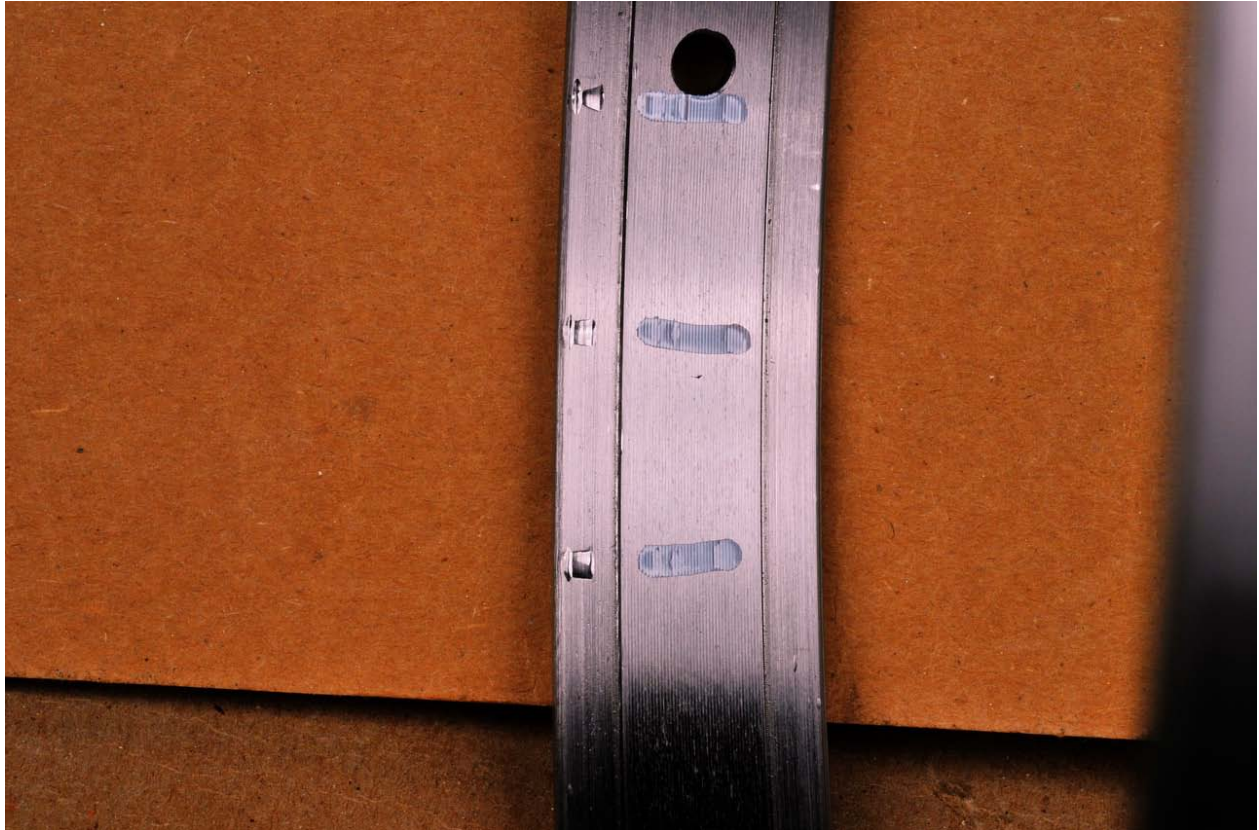
Figure No: 19 (NREL PIX 19867)

Failure mode: assembly damage

Failure mode severity: severe

Description: Three lines of plastic deformation at roller spacing indicate that the rollers of bearing C1 interfered with the spacer during assembly.

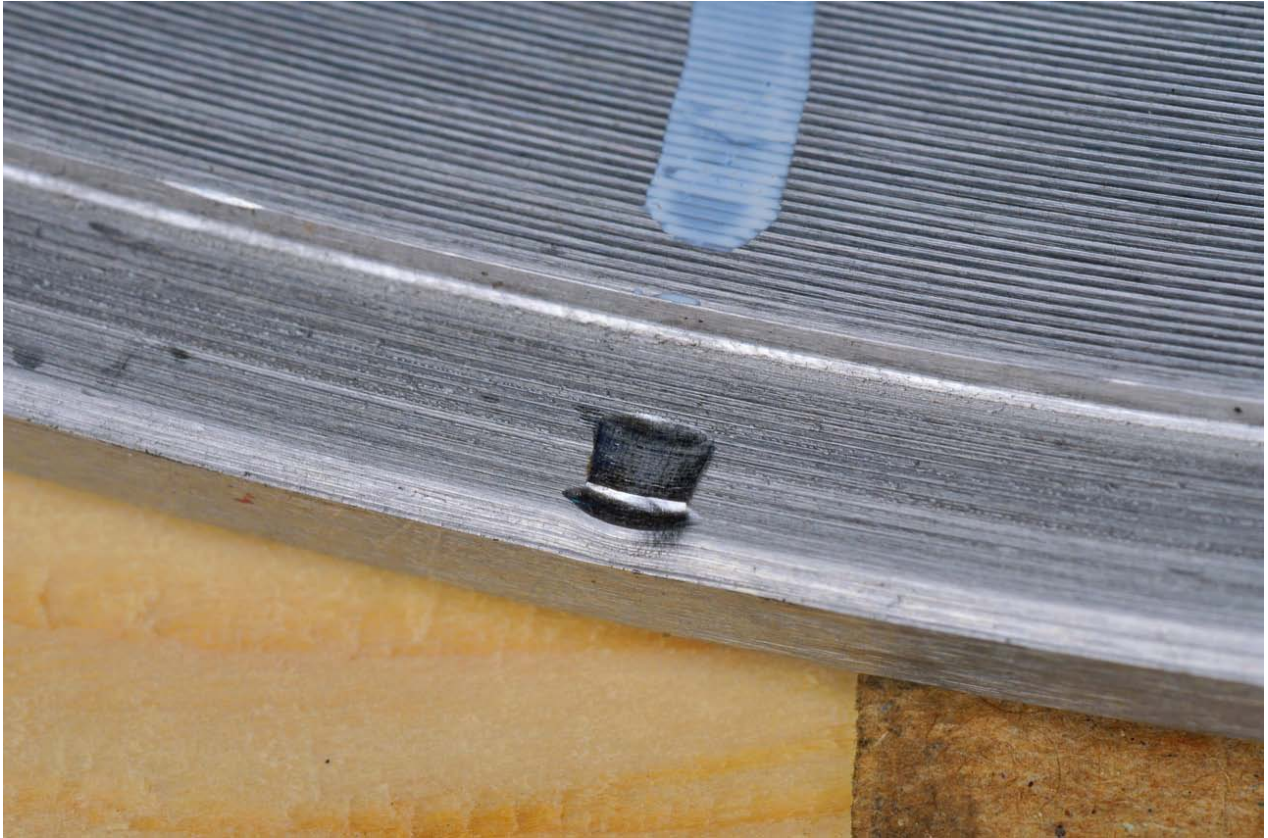
Figure No: 20 (NREL PIX 19868)

Failure mode: assembly damage

Failure mode severity: severe

Description: Closeup of the dent in the bearing C1/C2 spacer. The dent caused a raised area on the end face of the spacer.

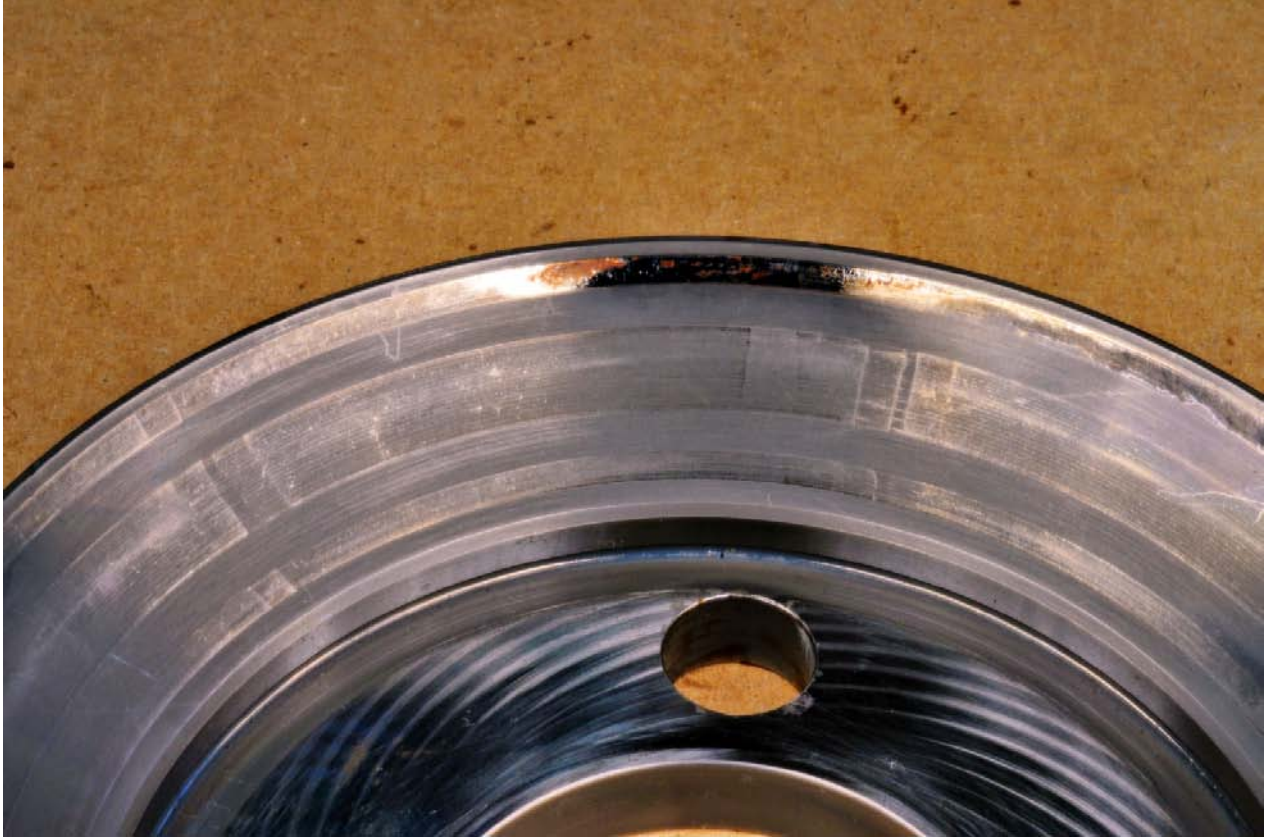
Figure No: 21 (NREL PIX 19846)

Failure mode: fretting corrosion

Failure mode severity: moderate

Description: Fretting corrosion occurred in a 60° sector near the outside diameter. The balance of the thrust surface had only mild wear.
