Gearbox Reliability Collaborative Gearbox 1 Failure Analysis Report

December 2010 – January 2011

R. Errichello and J. Muller
GEARTECH
Townsend, Montana

Subcontract Report
NREL/SR-5000-53062
February 2012

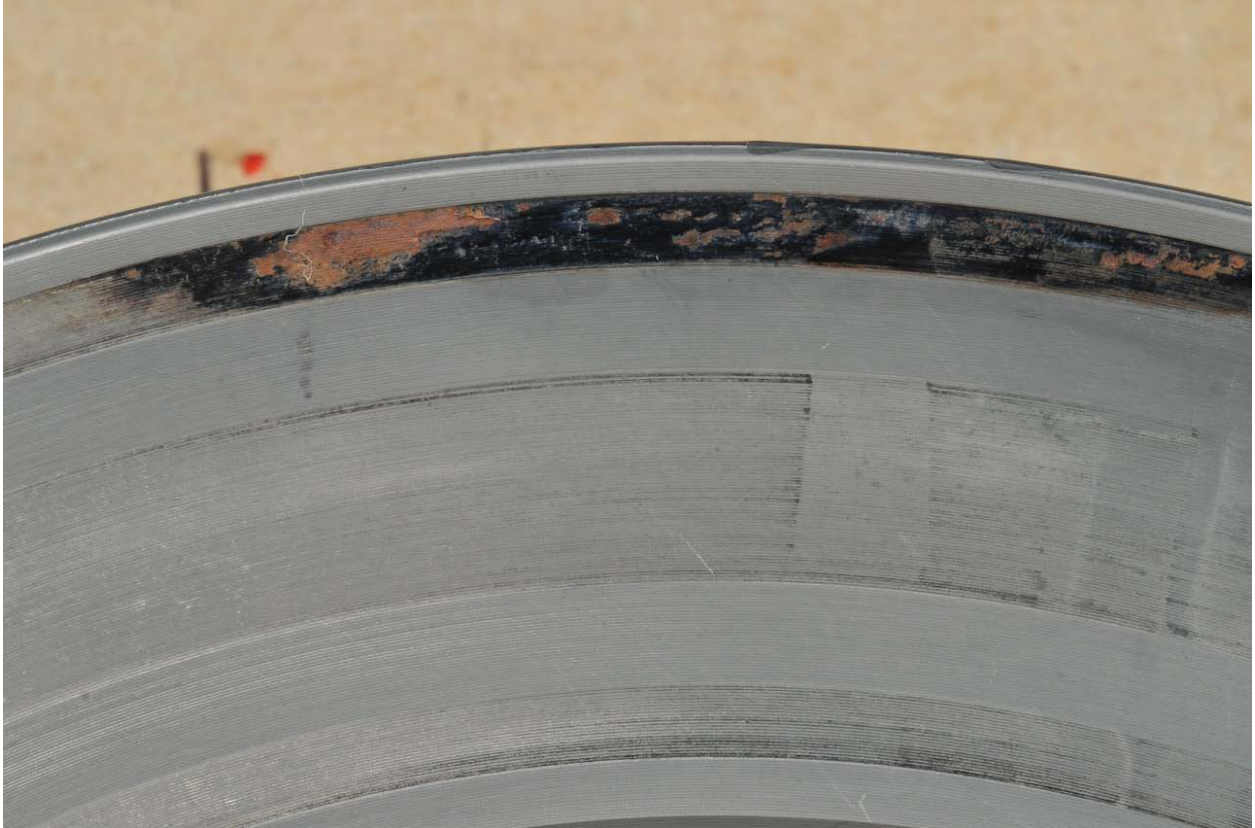
Figure No: 22 (NREL PIX 19847)

Failure mode: fretting corrosion

Failure mode severity: moderate

Description: Closeup of fretting corrosion.

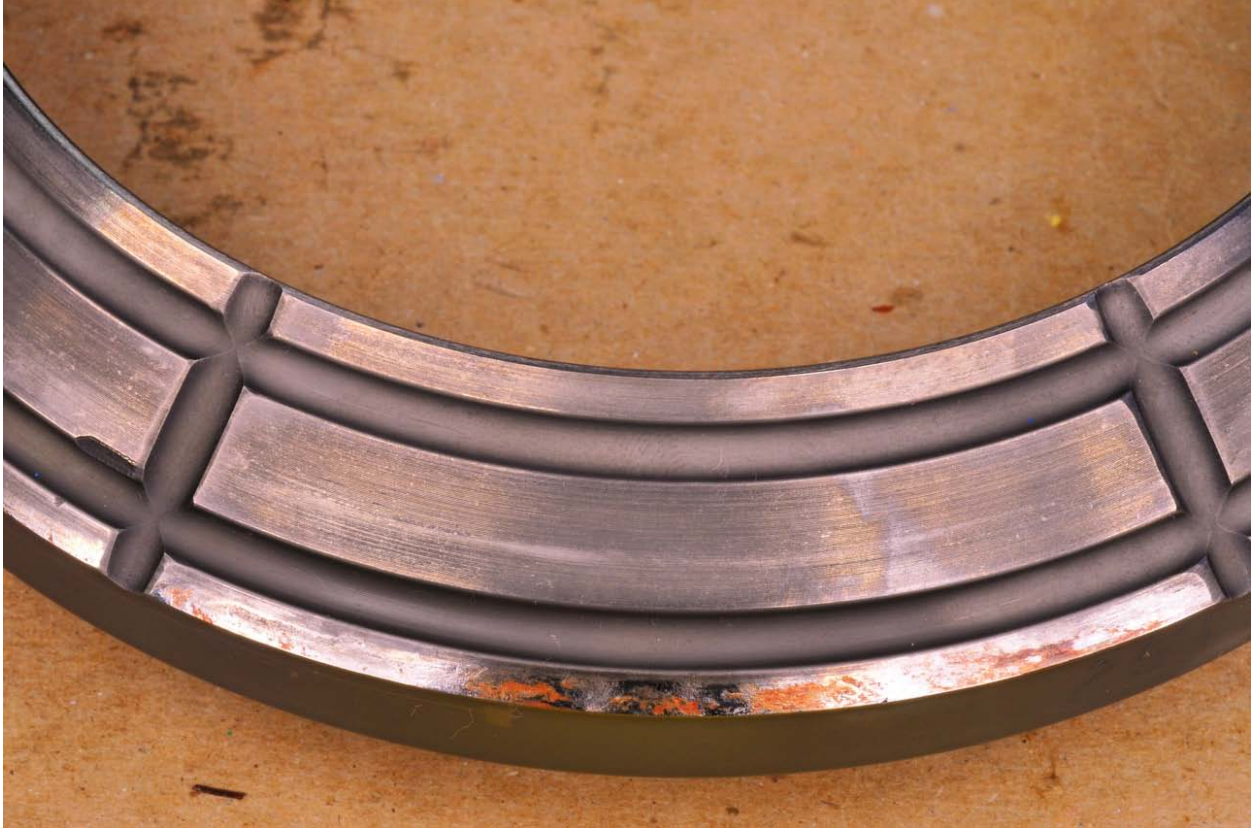
Figure No: 23 (NREL PIX 19848)

Failure mode: fretting corrosion

Failure mode severity: moderate

Description: Fretting corrosion occurred in a 60° sector near the outside diameter. The balance of the thrust surface had only mild wear.

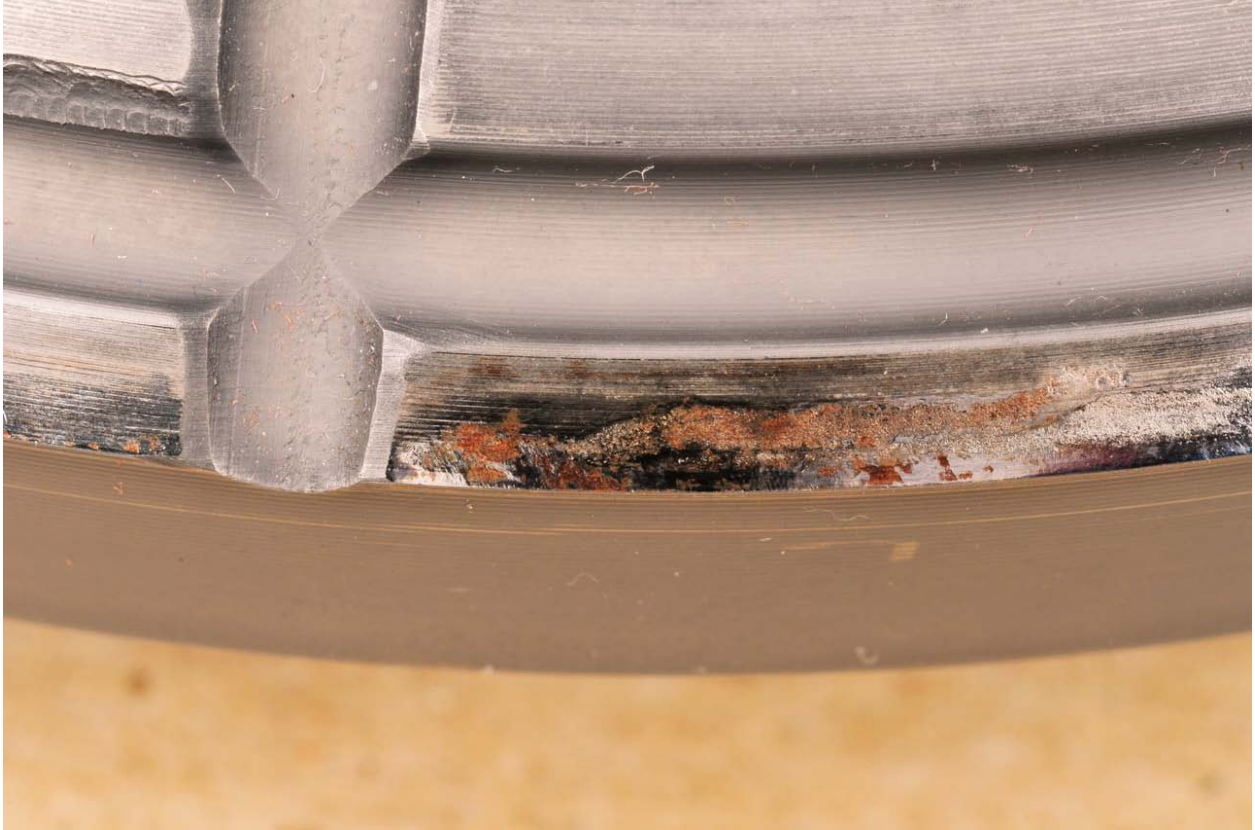
Figure No: 24 (NREL PIX 19849)

Failure mode: fretting corrosion

Failure mode severity: moderate

Description: Closeup of fretting corrosion.

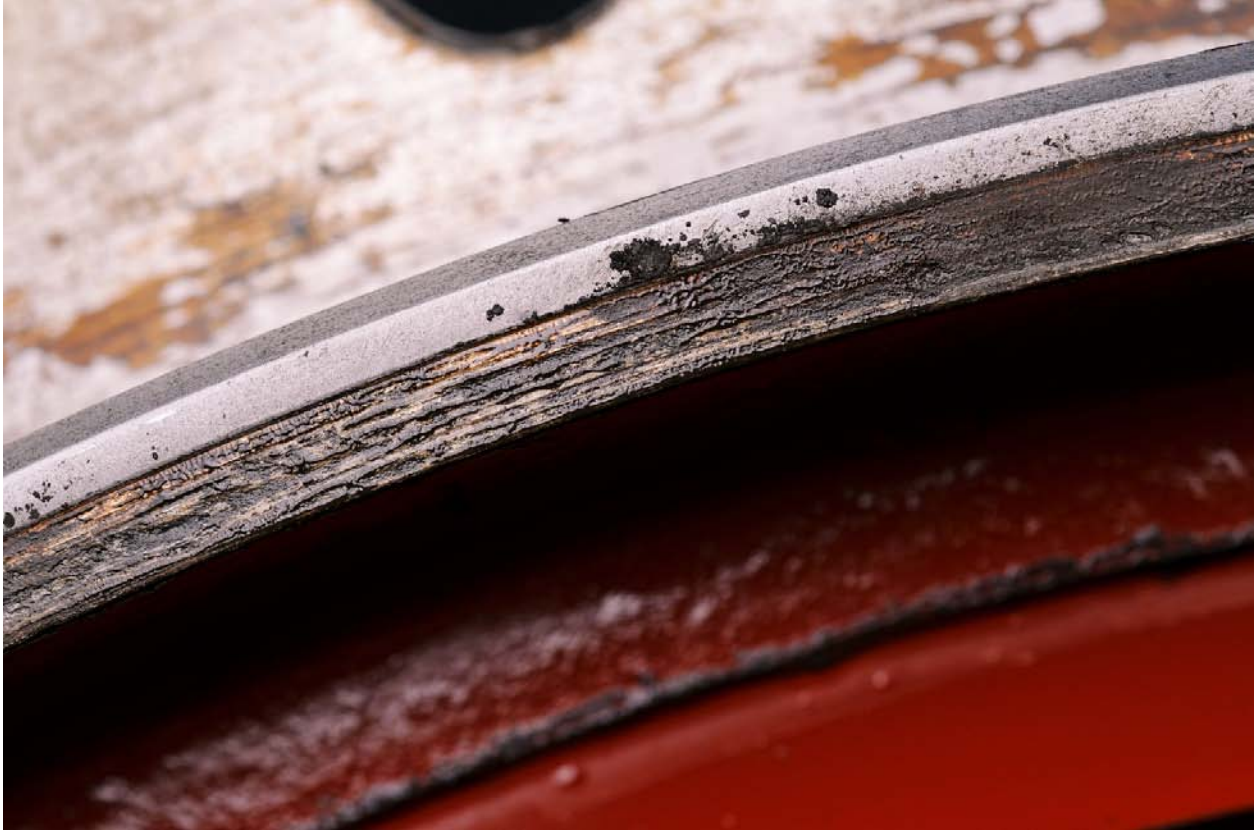
Figure No: 25 (NREL PIX 19839)

10. The interface between bearing H OR and the shoulder on bearing cap H had severe fretting corrosion. The root cause of the fretting corrosion was probably the loose fit of bearing H OR.

Failure mode: fretting corrosion

Failure mode severity: severe

Description: Closeup of fretting corrosion. Fretting corrosion occurred in a small sector on the face of the bearing H retainer thrust shoulder that locates bearing H OR.

10. Review the design of the fit of the OR of bearing H and the bearing cap for bearing H and revise as necessary to eliminate fretting corrosion at the interface between bearing H OR and the shoulder on bearing cap H.

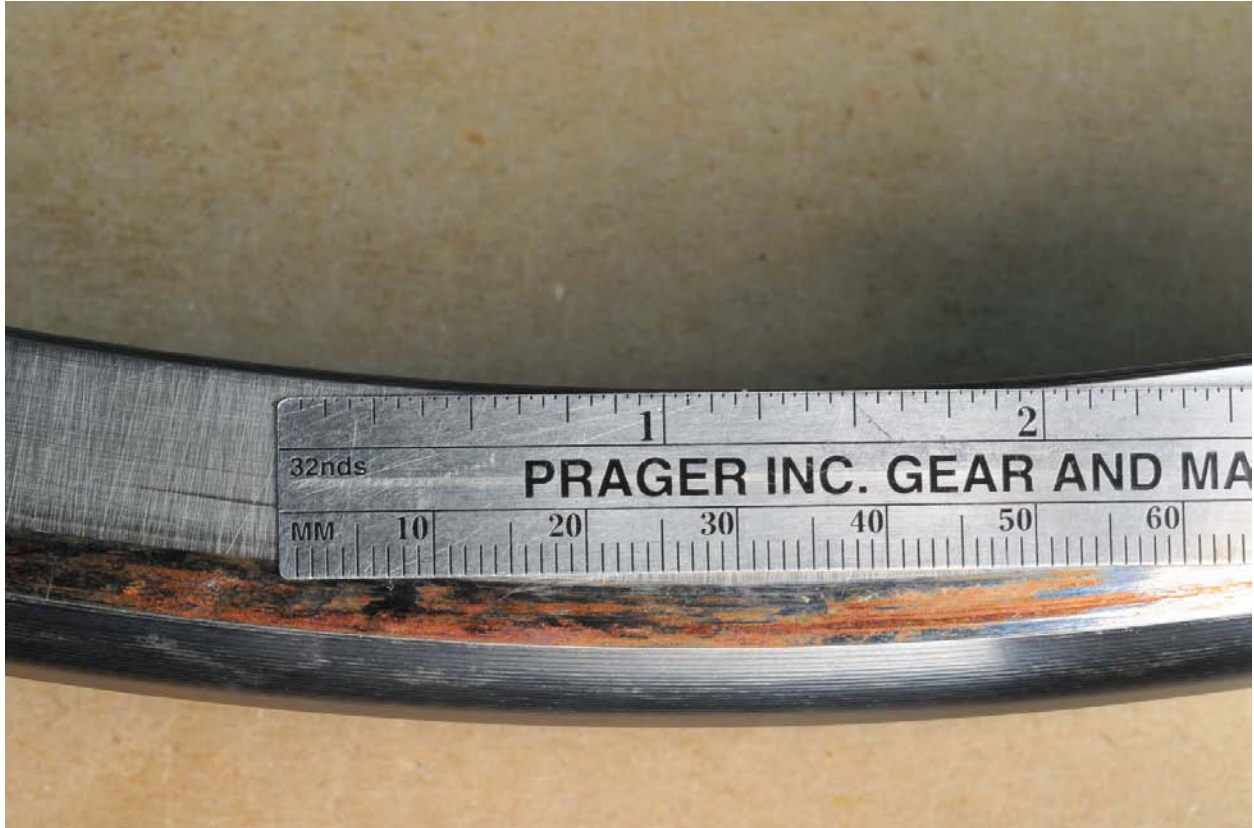
Figure No: 26 (NREL PIX 19843)

Failure mode: fretting corrosion

Failure mode severity: severe

Description: Closeup of fretting corrosion. Fretting corrosion occurred in a small sector on the end face of bearing H OR.

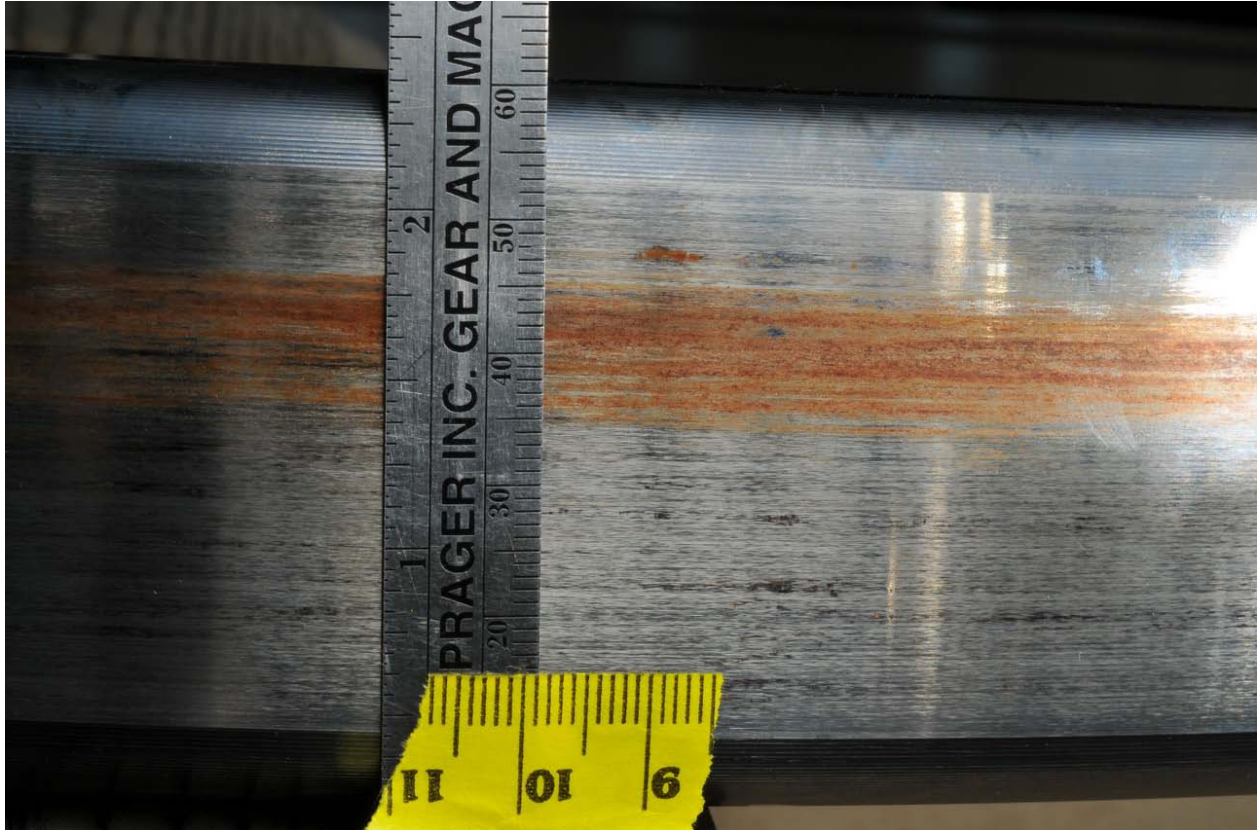
Figure No: 27 (NREL PIX 19844)

Failure mode: fretting corrosion

Failure mode severity: severe

Description: Fretting corrosion occurred in a 140° sector on the outside diameter of bearing H OR.

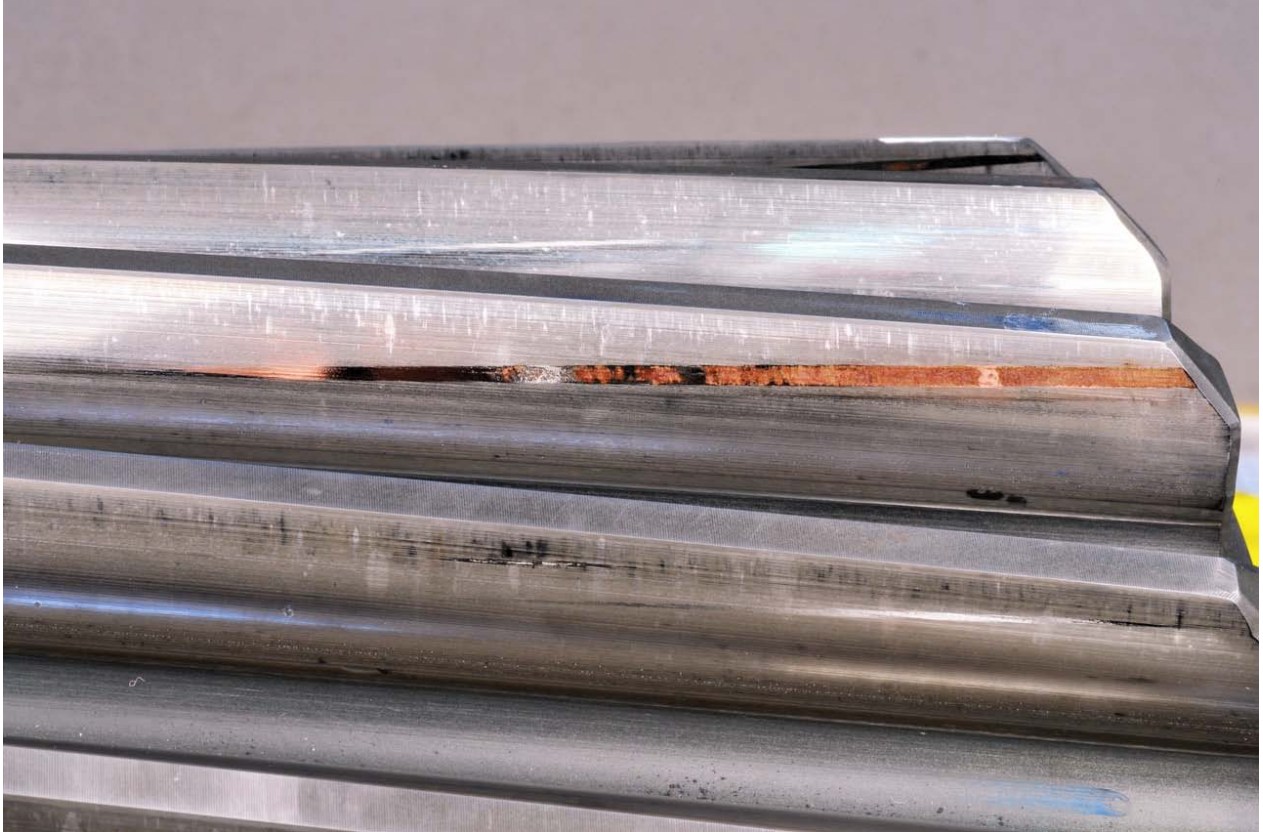
Figure No: 28 (NREL PIX 19850)

Failure mode: fretting corrosion

Failure mode severity: severe

Description: Fretting corrosion occurred along a line of contact.

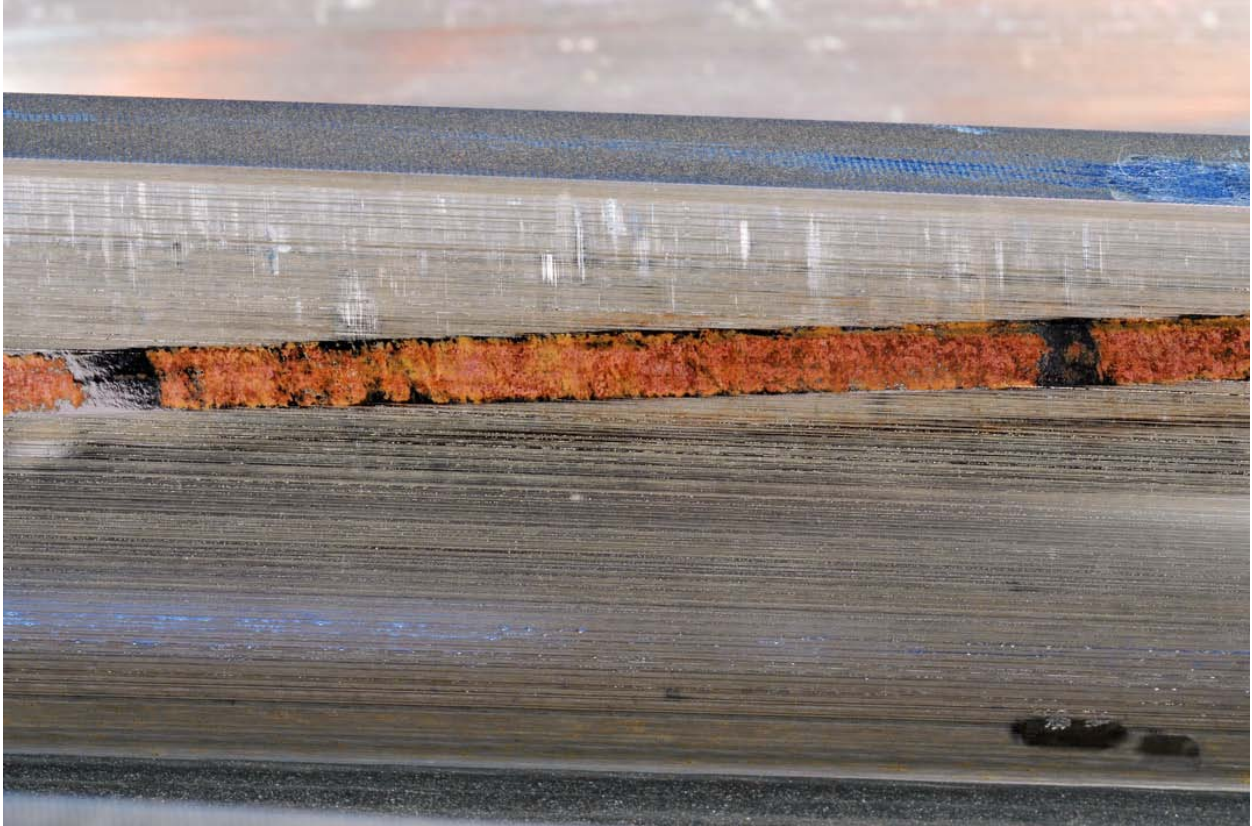
Figure No: 29 (NREL PIX 19851)
Scale: 3.2X
Component: sun pinion
Failure mode: fretting corrosion
Failure mode severity: severe
Description: Closeup view of fretting corrosion.

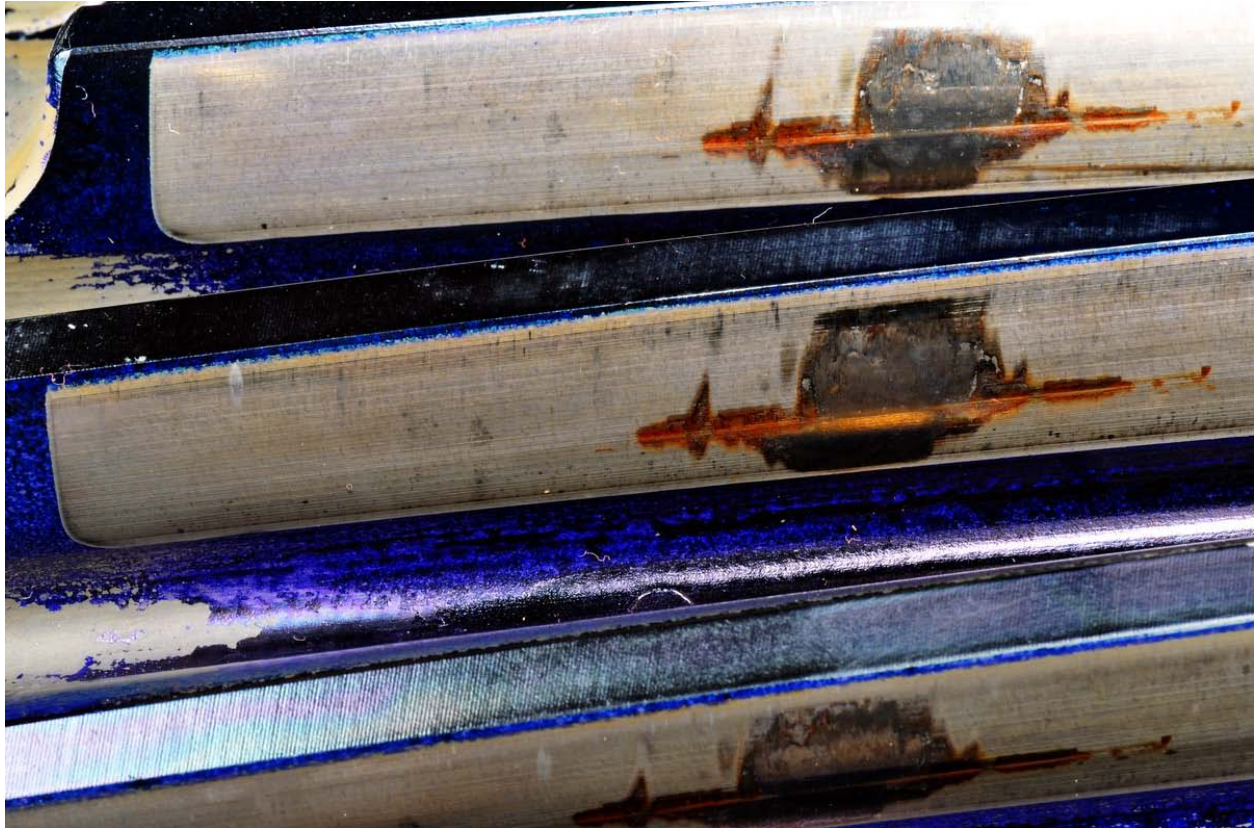
Figure No: 30 (NREL PIX 19862)

Failure mode 1: fretting corrosion

Failure mode severity 1: severe

Failure mode 2: polishing wear

Failure mode severity 2: severe (local)

Failure mode 3: scuffing

Failure mode severity 3: severe (local)

Description: Fretting corrosion, polishing, and scuffing. Damage was imprinted on all teeth because the gearset had a hunting gear ratio.

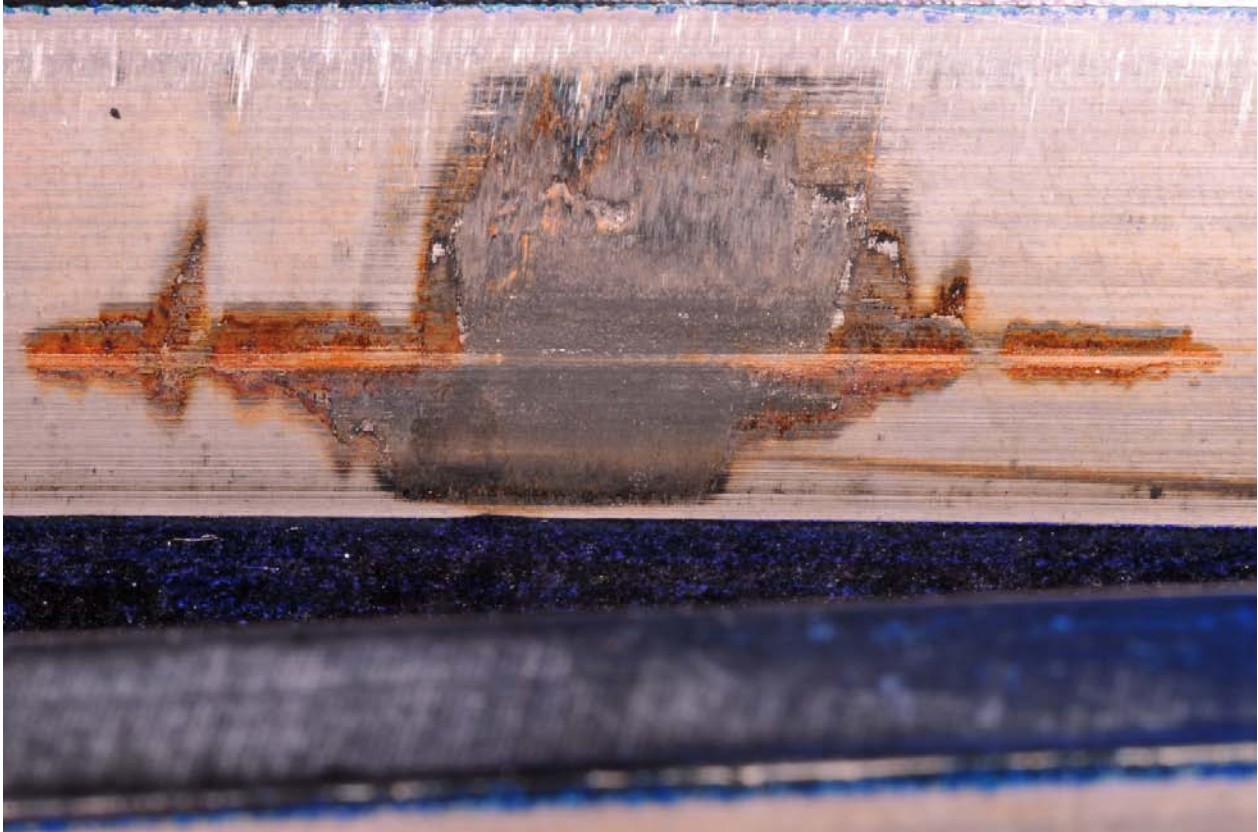
Figure No: 31 (NREL PIX 19863)

Failure mode 1: fretting corrosion

Failure mode severity 1: severe

Failure mode 2: polishing wear

Failure mode severity 2: severe (local)

Failure mode 3: scuffing

Failure mode severity 3: severe (local)

Description: Closeup view of the fretting corrosion, polishing, and scuffing.

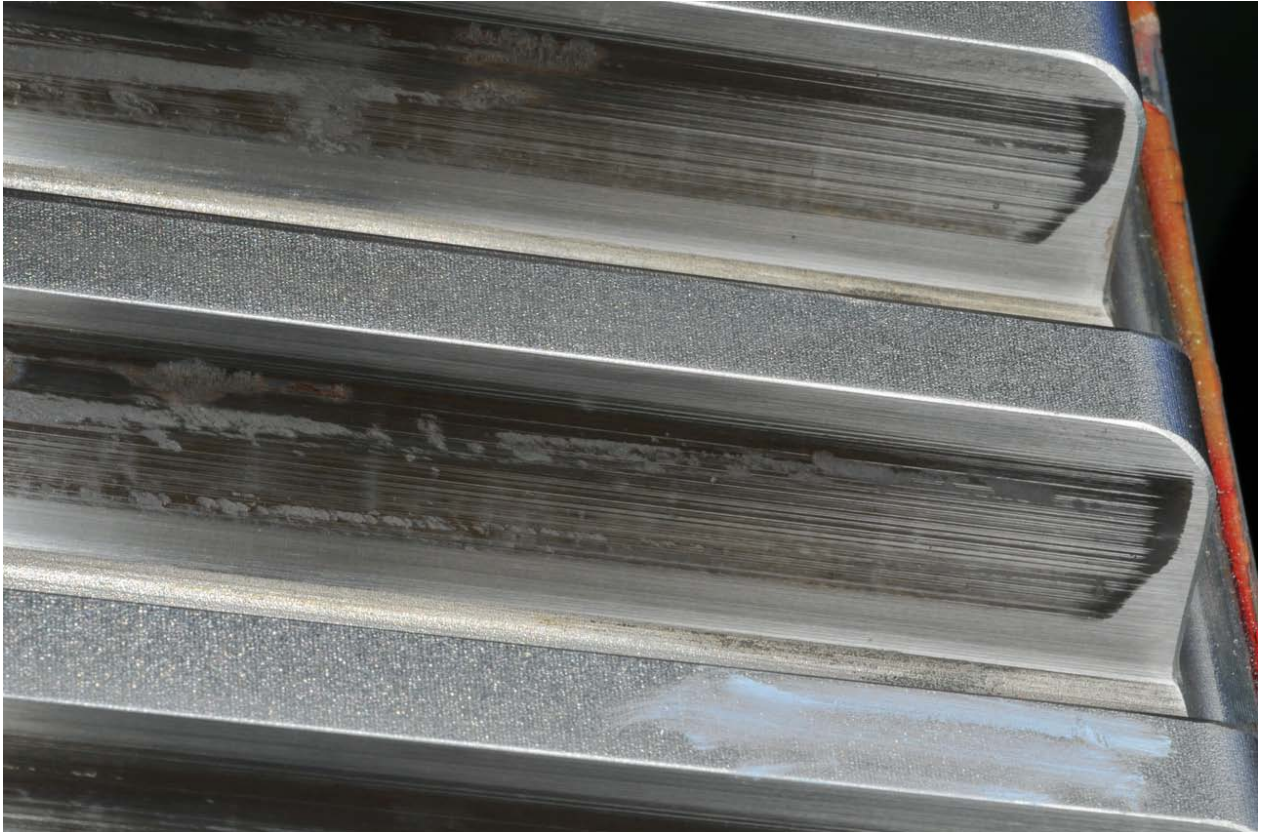
Figure No: 32 (NREL PIX 19854)

Failure mode 1: scuffing

Failure mode severity 1: moderate (local)

Failure mode 2: polishing

Failure mode severity 2: moderate

Description: Closeup view of polishing at the generator end of the teeth.

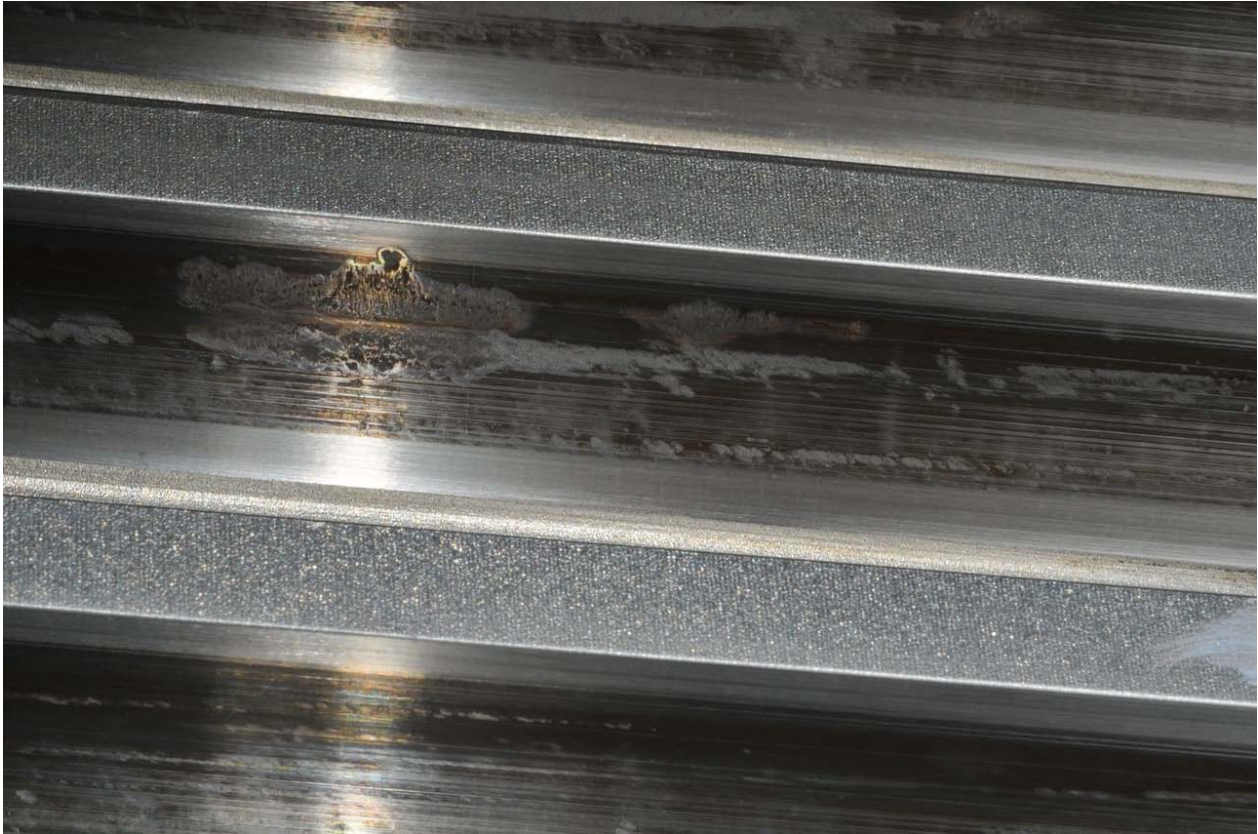
Figure No: 33 (NREL PIX 19855)

Failure mode 1: scuffing

Failure mode severity 1: moderate (local)

Failure mode 2: polishing

Failure mode severity 2: moderate

Description: Closeup view of scuffing near the midface of the teeth.

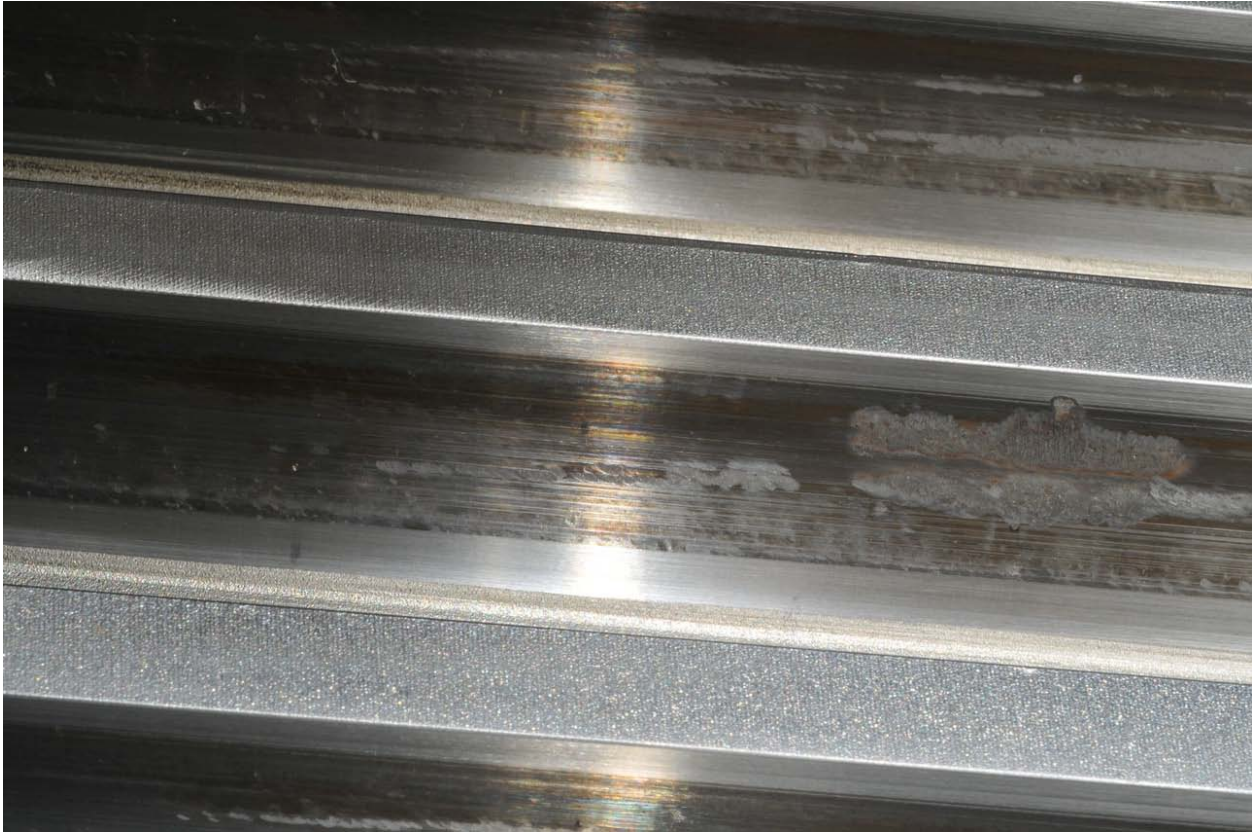
Figure No: 34 (NREL PIX 19856)

Failure mode 1: scuffing

Failure mode severity 1: moderate (local)

Failure mode 2: polishing

Failure mode severity 2: moderate

Description: Closeup view of scuffing near the midface of the teeth.

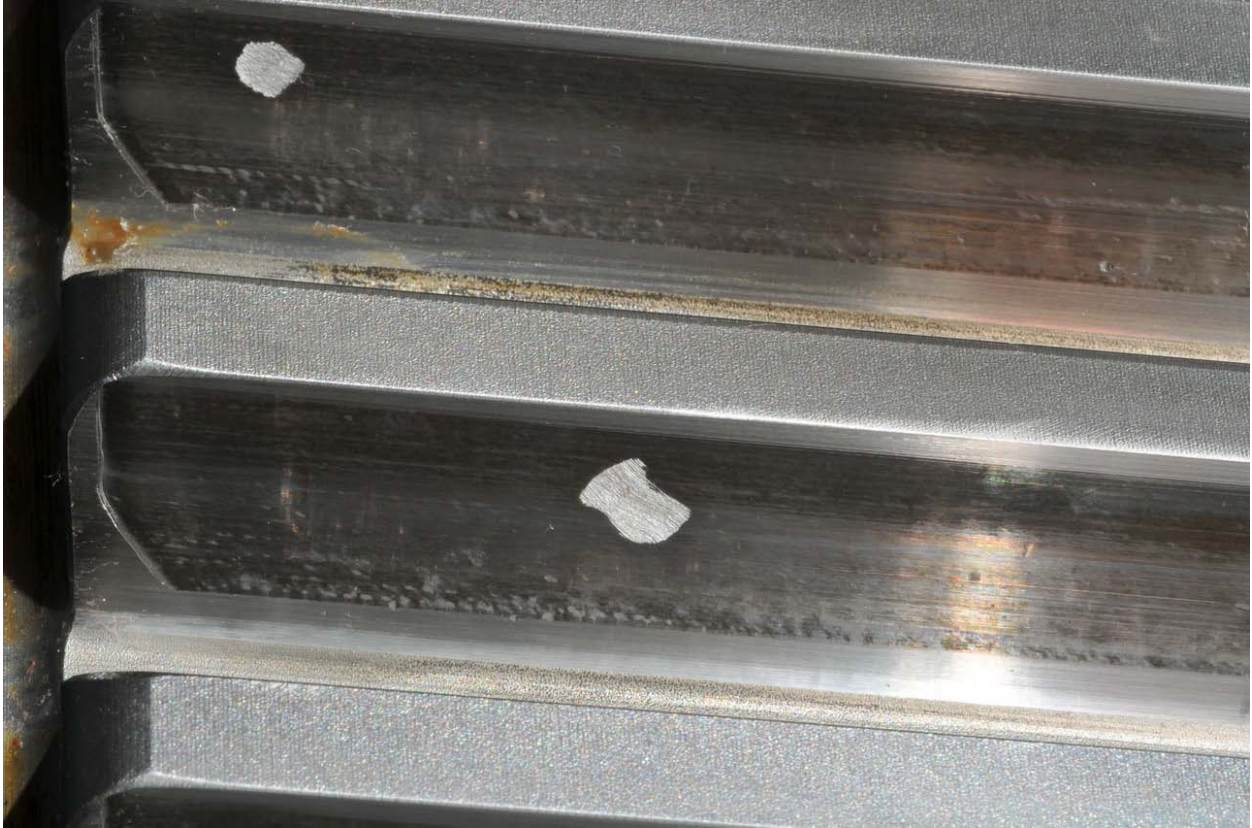
Figure No: 35 (NREL PIX 19857)

Failure mode 1: scuffing

Failure mode severity 1: moderate (local)

Failure mode 2: polishing

Failure mode severity 2: severe

Description: Closeup view of severe polishing wear at the rotor end of the teeth. Two original, hand dressed macropits are shown. Polishing wear removed all traces of the grind marks and created a wear step at the end of the contact.

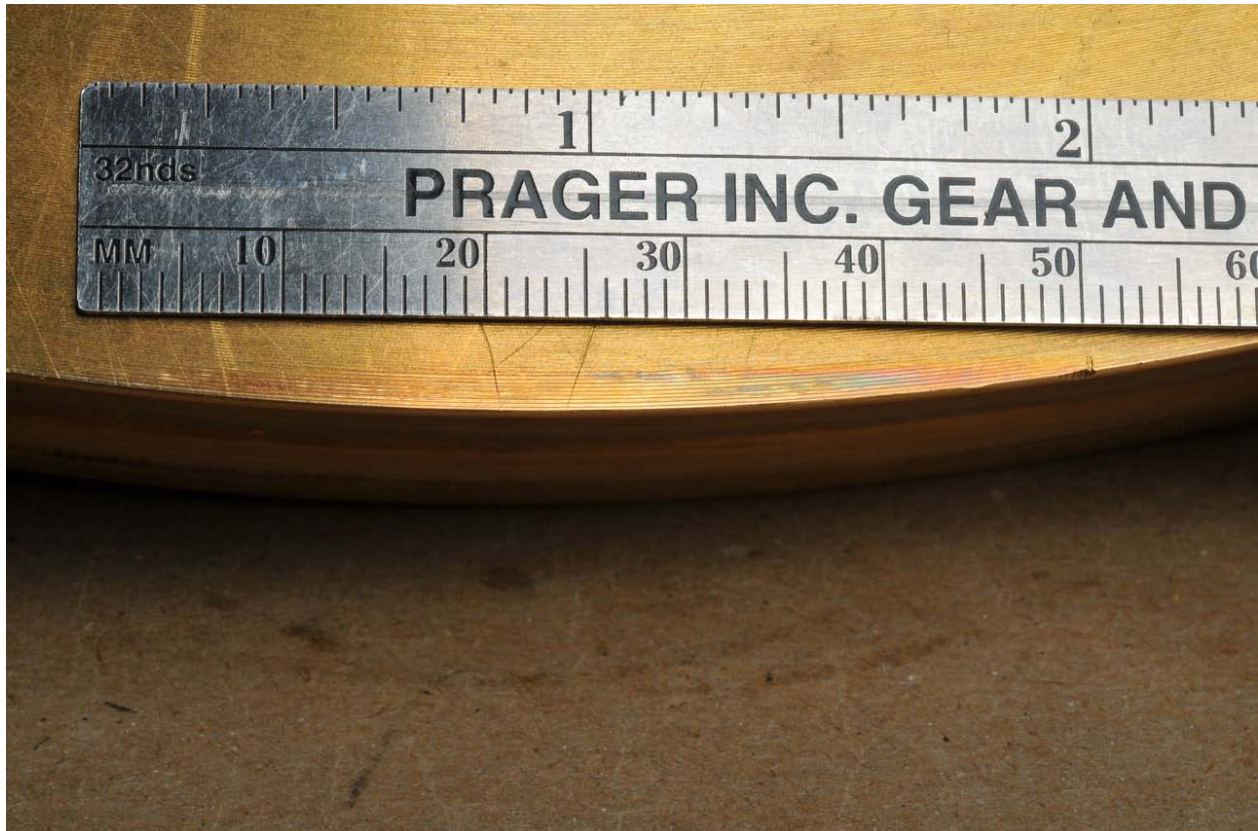
Figure No: 36 (NREL PIX 19840)

Failure mode: polishing

Failure mode severity: mild (local)

Description: Closeup view of polishing near the outside diameter of the rubbing face. The contact area was only about 50 mm long.

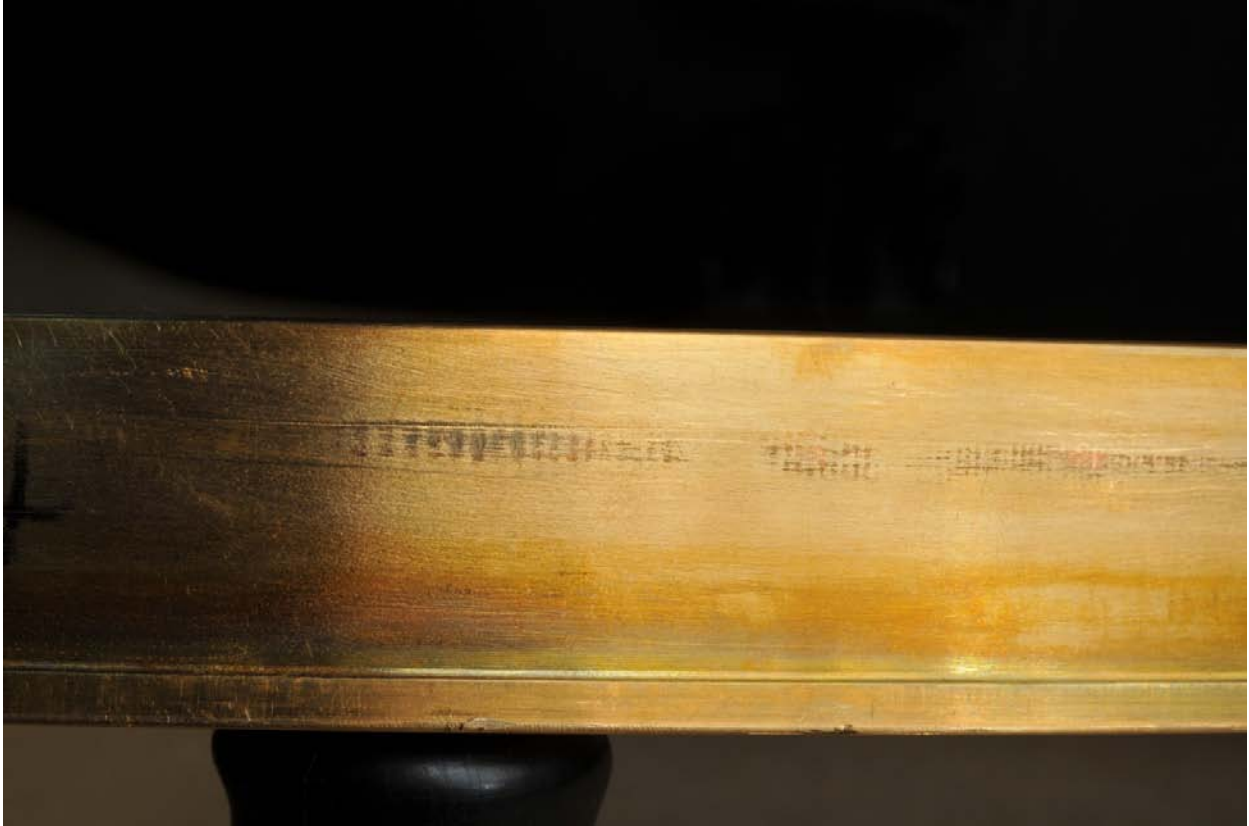
Figure No: 37 (NREL PIX 19841)

Failure mode: polishing

Failure mode severity: mild (local)

Description: Closeup view of polishing on the outside diameter. The marks occurred when the ring cocked and jammed.

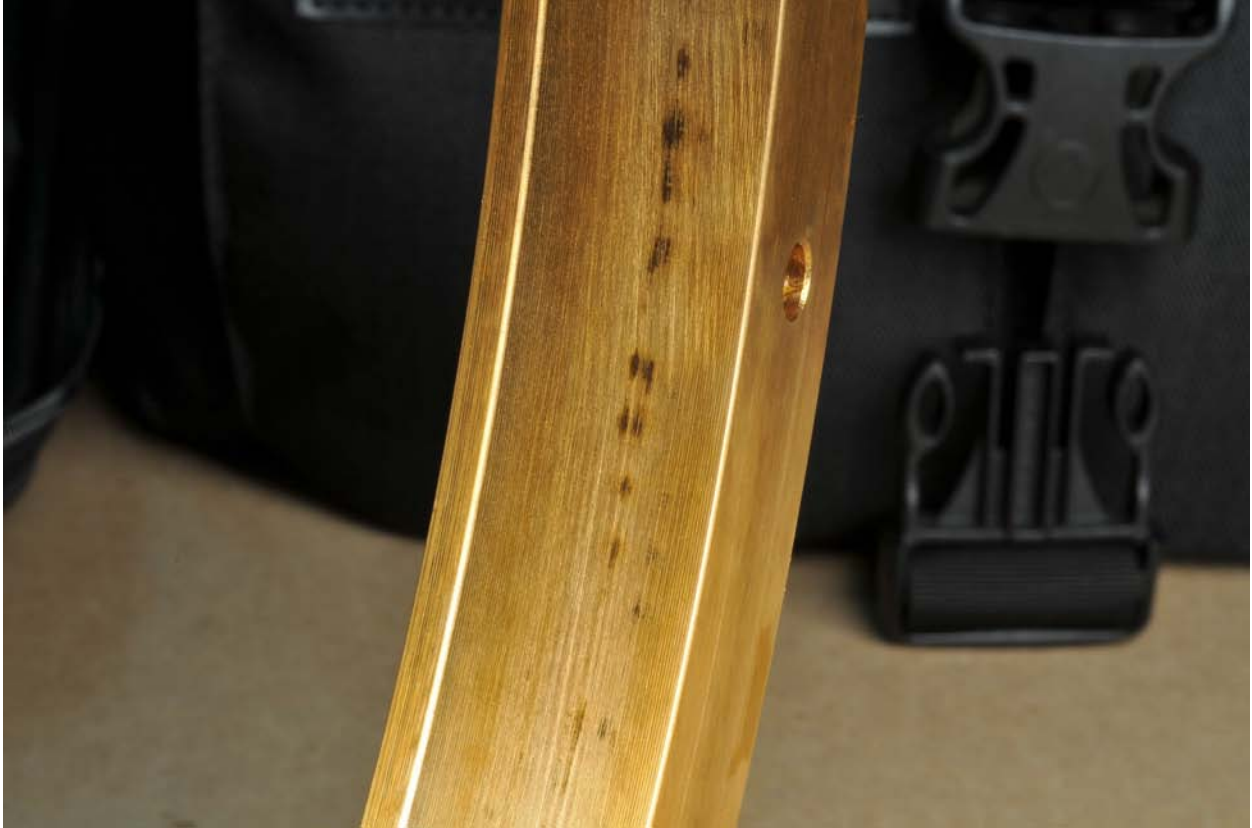
Figure No: 38 (NREL PIX 19842)

Failure mode: polishing

Failure mode severity: mild (local)

Description: Closeup view of polishing on the bore. The marks occurred when the ring cocked and jammed.

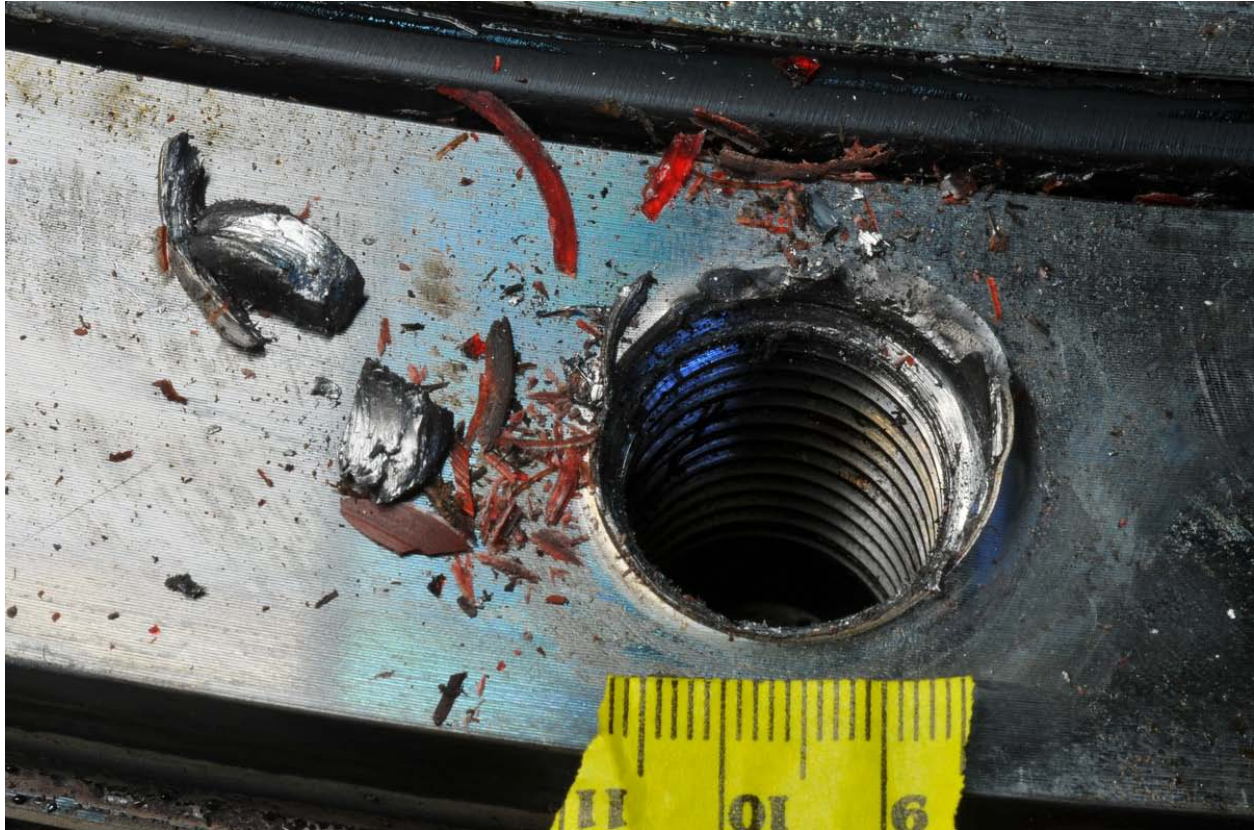
Figure No: 39 (NREL PIX 19845)

Failure mode: plastic deformation

Failure mode severity: severe

Description: Closeup view of stripped thread. The failure occurred when the bolt jammed during removal.

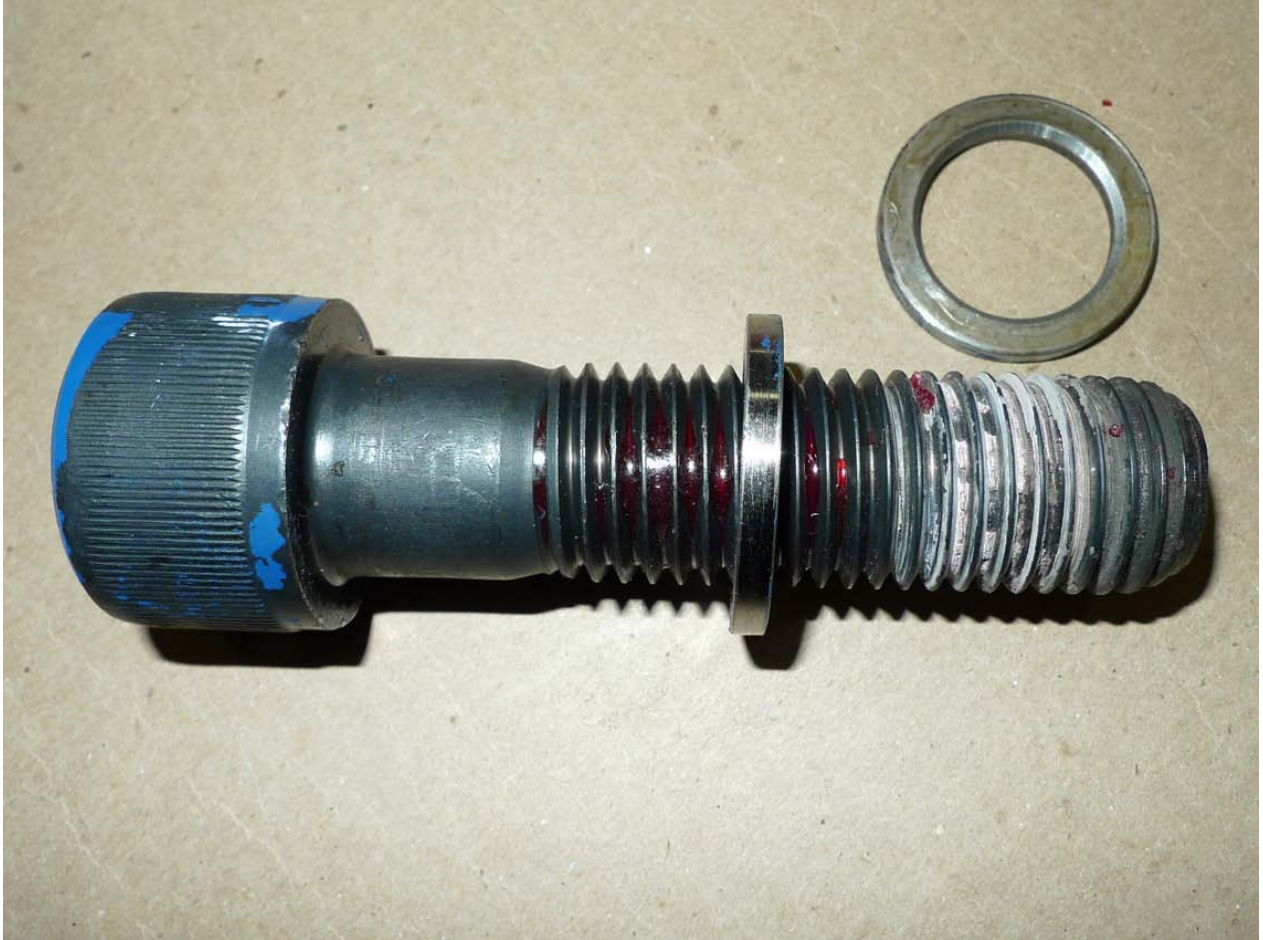
Figure No: 40 (NREL PIX 19836)

Description: Closeup view of the bolt and washer. The washer outside diameter had been reduced by machining to a diameter about equal to the bolt shoulder.

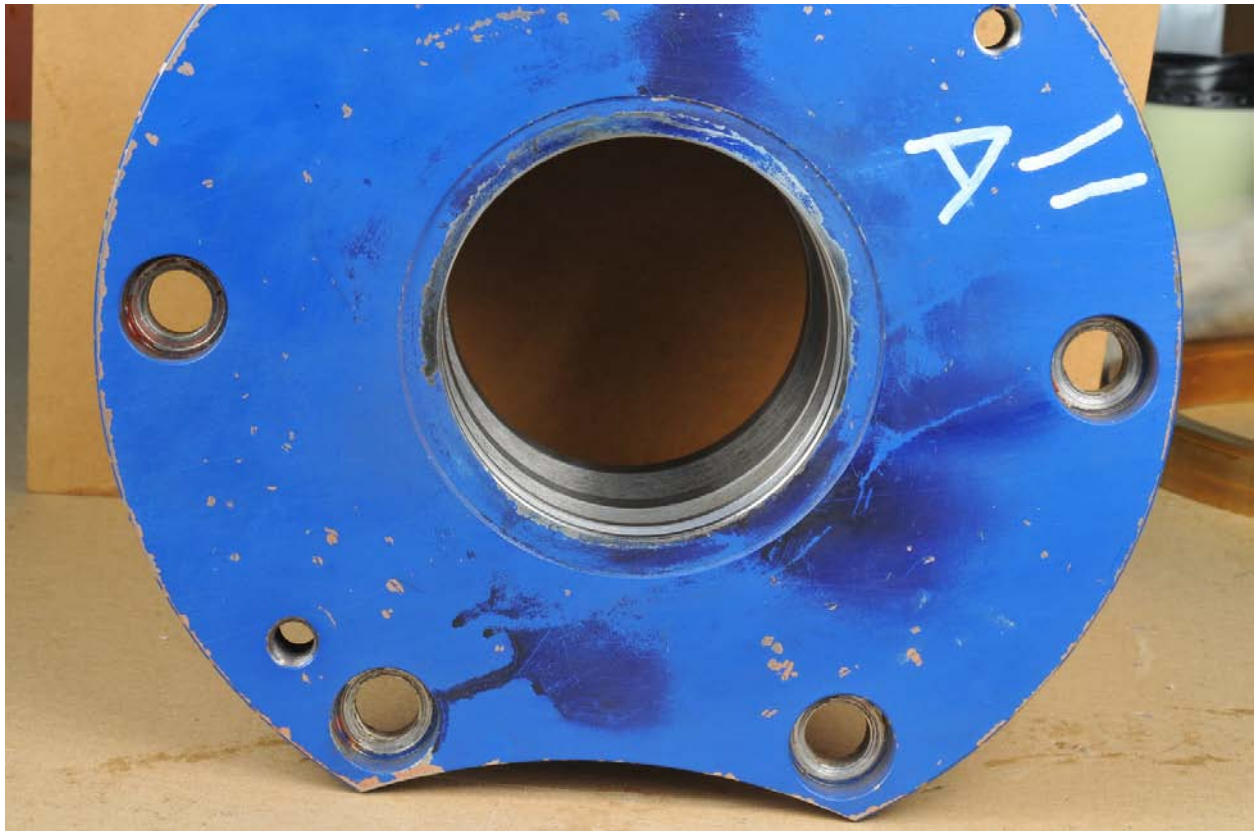
Figure No: 41 (NREL PIX 19869)

Description: Closeup view of cap face. There was no V-ring and no wear track from a V-ring.
