Gearbox Reliability Collaborative Gearbox 1 Failure Analysis Report

December 2010 – January 2011

R. Errichello and J. Muller
GEARTECH
Townsend, Montana

Subcontract Report
NREL/SR-5000-53062
February 2012

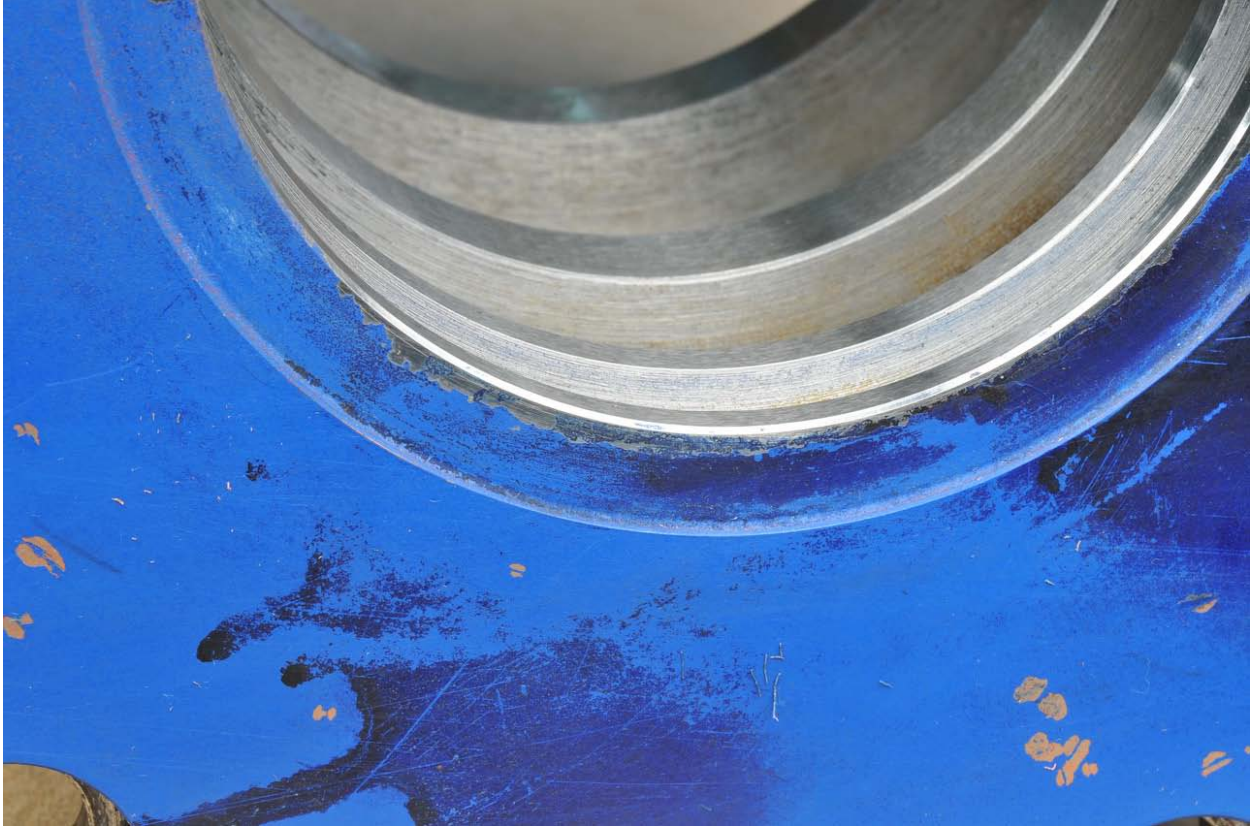
Figure No: 42 (NREL PIX 19870)

21. There was no external V-ring and no felt seal on the HS labyrinth. This allowed the gearbox to breathe through the labyrinth and ingest moisture and dust.

Description: Closeup view of felt seal groove. There was no felt seal and no wear track on the HSP from a felt seal.

21. Add an external V-ring and felt seal to the HS labyrinth.
22. Add an external V-ring to the LS labyrinth.
23. Coat the bore and outside diameter of the carrier extension with rust preventative whenever the gearbox is disassembled from the rotor shaft.

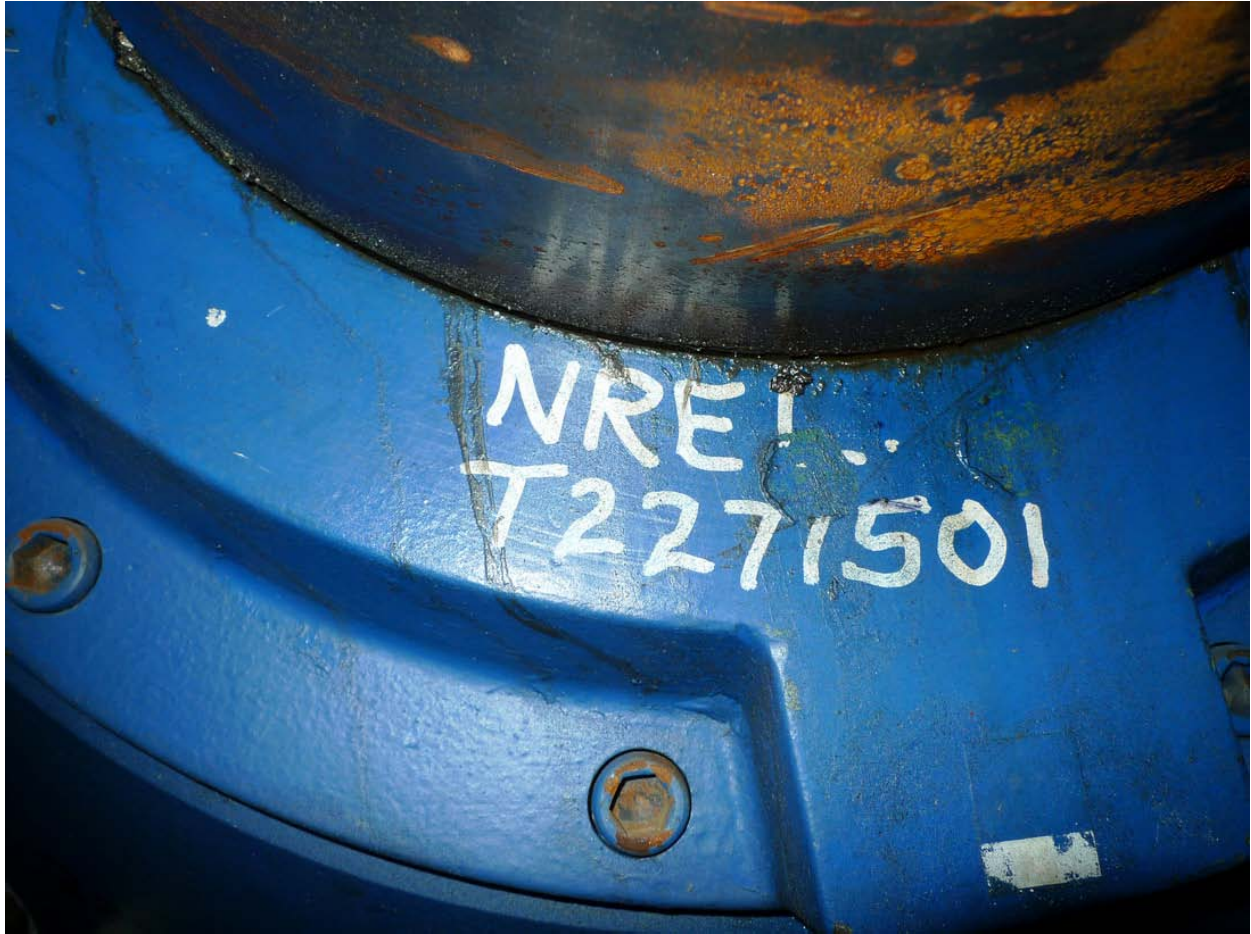
Figure No: 43 (NREL PIX 19835)

Description: Closeup view of cap face. There was no V-ring and no wear track from a V-ring. Oil on the cap face shows minor oil leaks. Rust is evident on the outside diameter of the carrier extension.
